# PRE-PURCHASE CONDITION SURVEY REPORT

## *Mean Time*

<b>Date</b>	07/02/26
<b>Report No.</b>	026/PSS/001

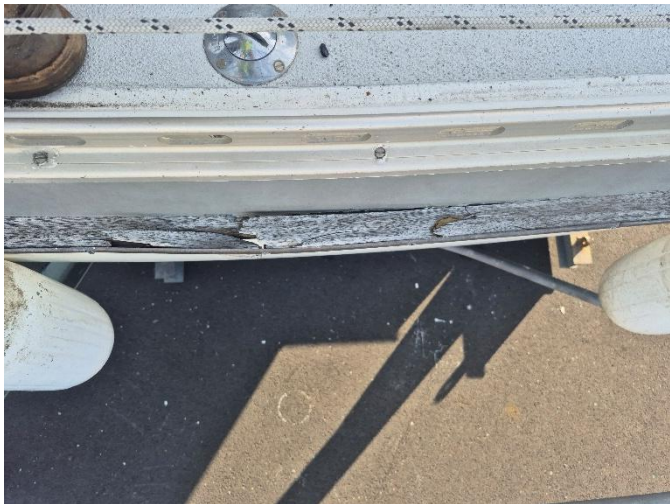
**DEF C:** Rubbing band seen damaged on stbd side.

Damaged rubbing band

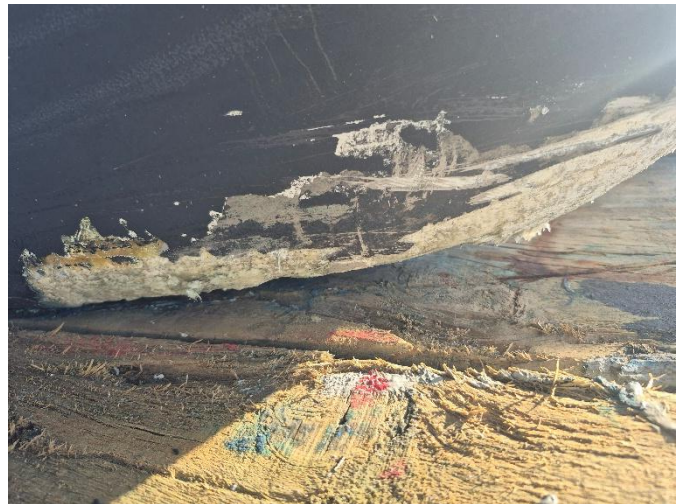
**DEF B:** Keel fin recently has run aground and has cause some damage. This is regarded as minor and was being repaired at the time of survey.

Keel Damage

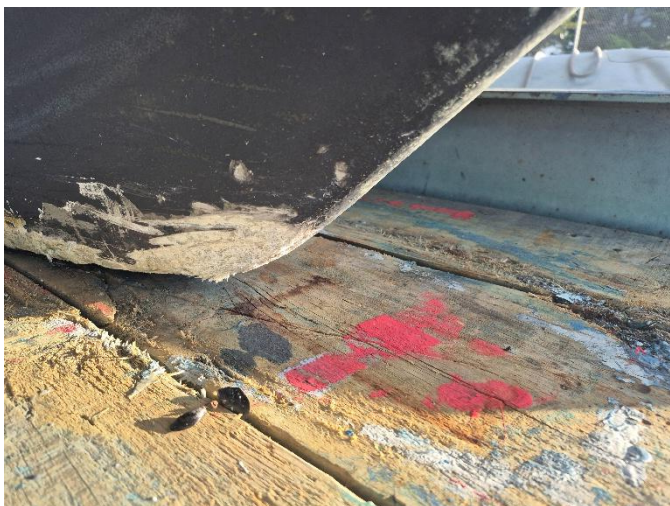
Keel Damage

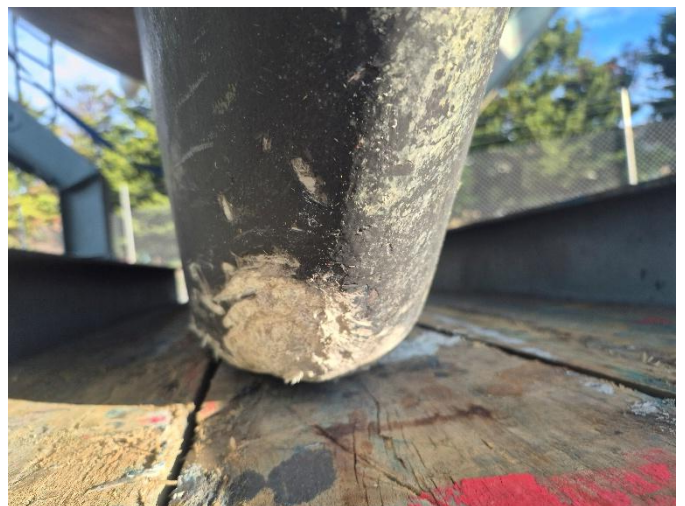
Keel Damage

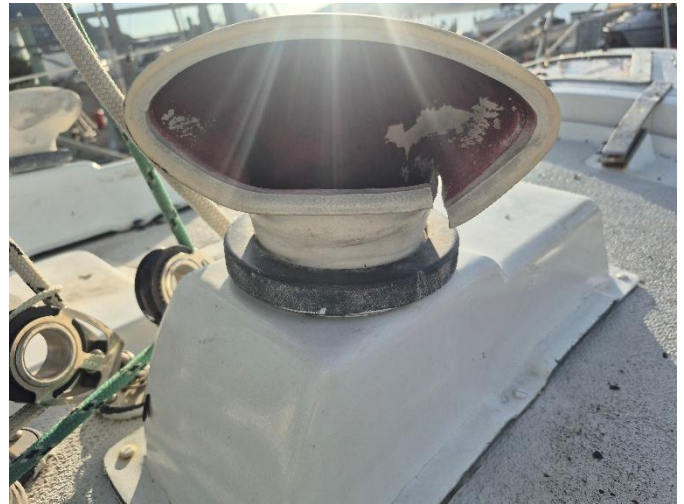
**DEF C:** Vent head slightly damaged on stbd side.

Damaged vent head
