## PRE-PURCHASE CONDITION SURVEY REPORT

*Kokah*

Date	11/09/25
Report No.	025/PSS/006

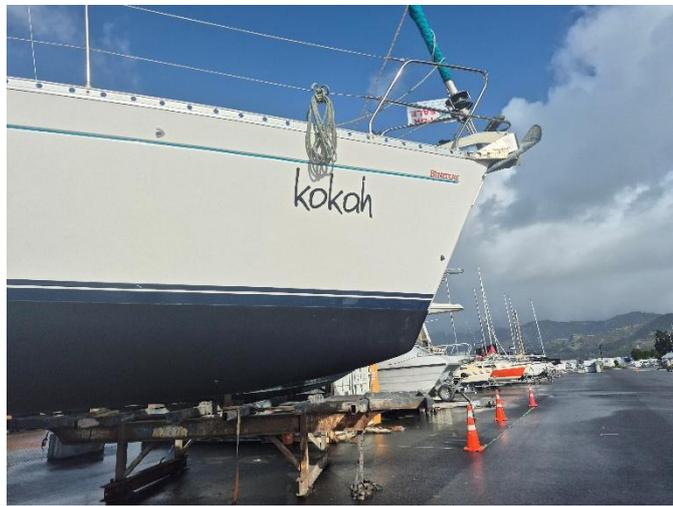
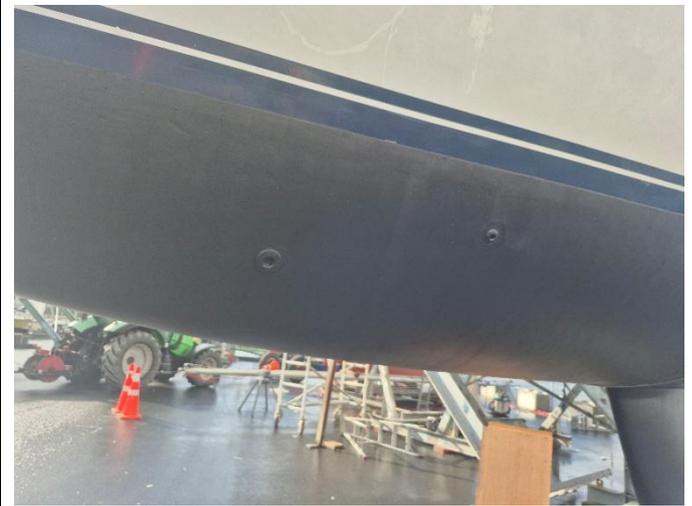
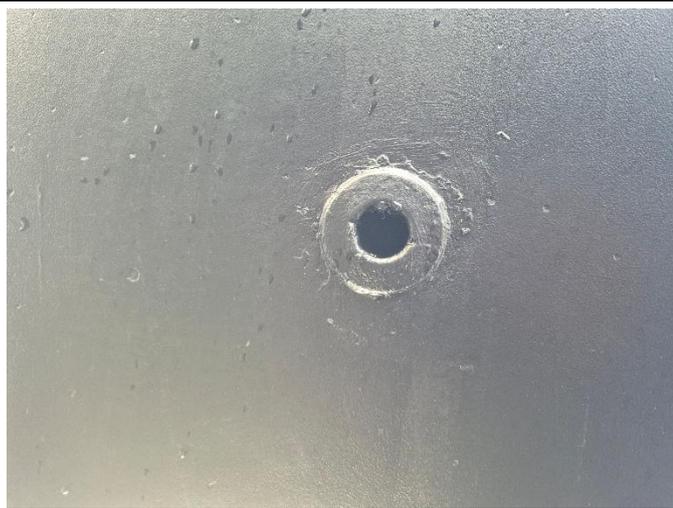
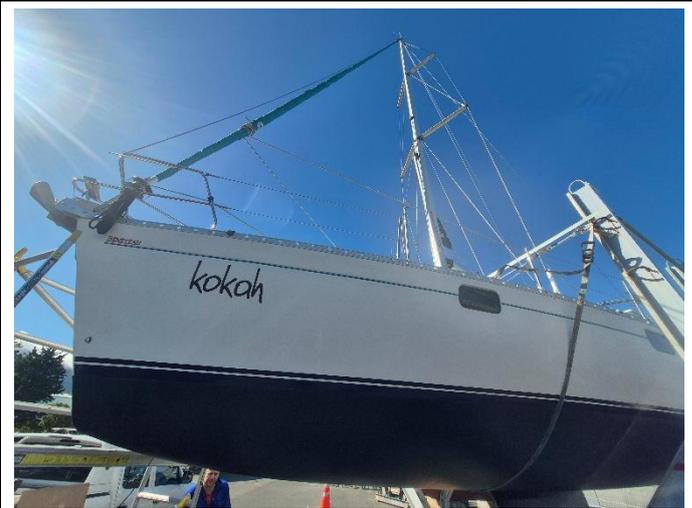
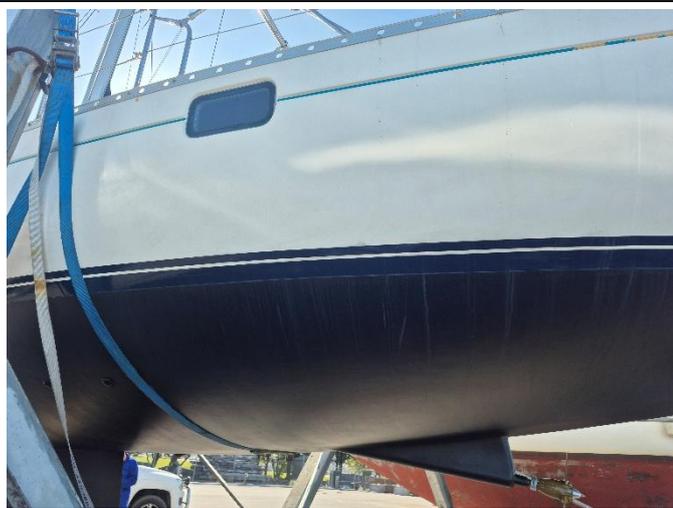
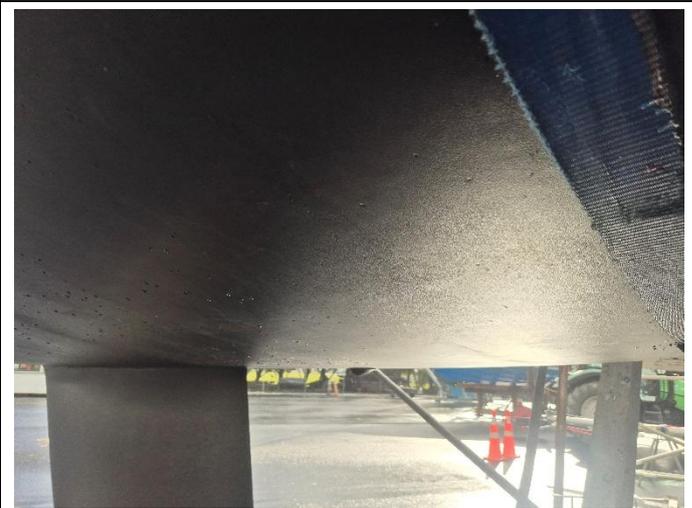
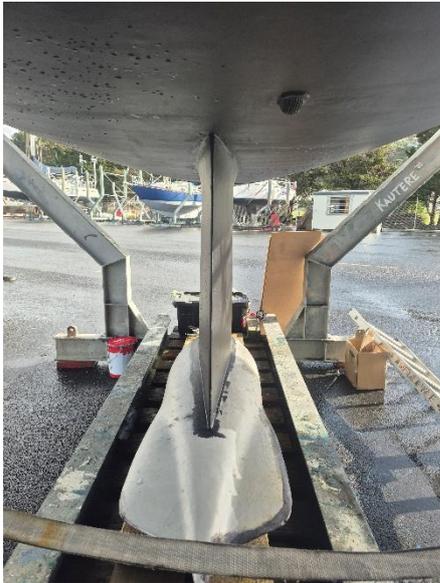
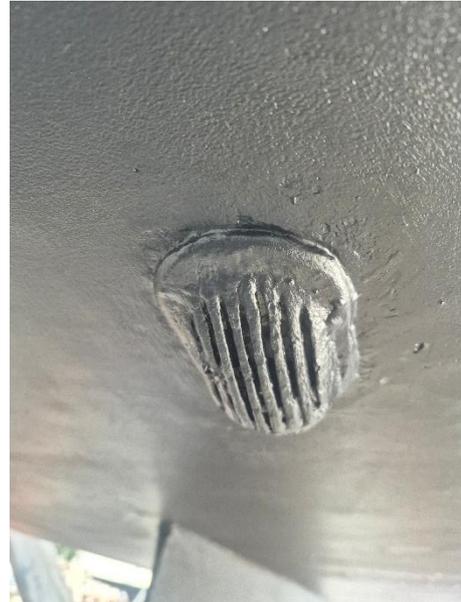
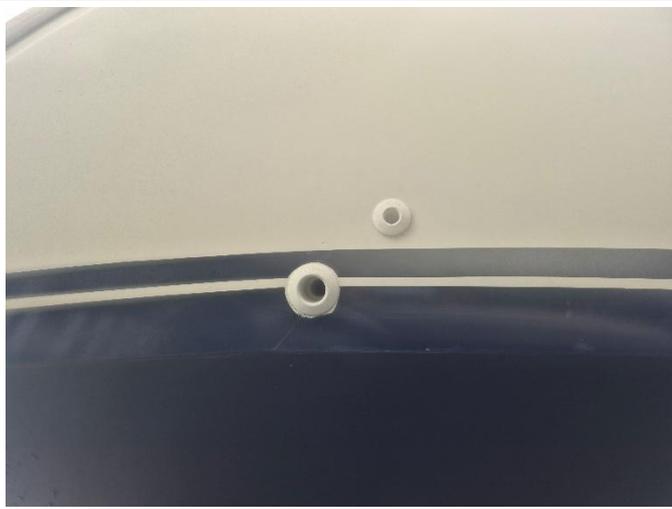
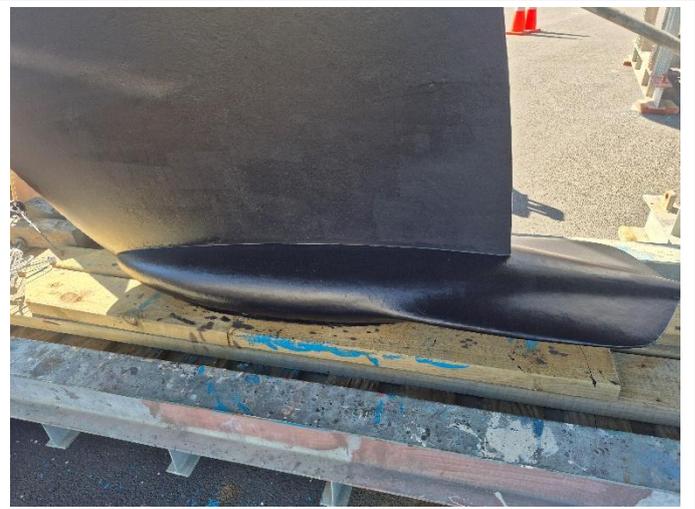
## 7. Hull, Coatings & Submerged Fittings

GRP hull had suffered from mild, shallow, osmosis blisters that have all been ground out and repaired leaving a very good finish. No other damage or deformation observed

Inlets and discharges in good condition and free from biofouling. Suitable backflow protection in place.

Echo sounder transducer appears in sound condition.

Keel and bulb seen in good condition with no signs of cracking between keel and hull.

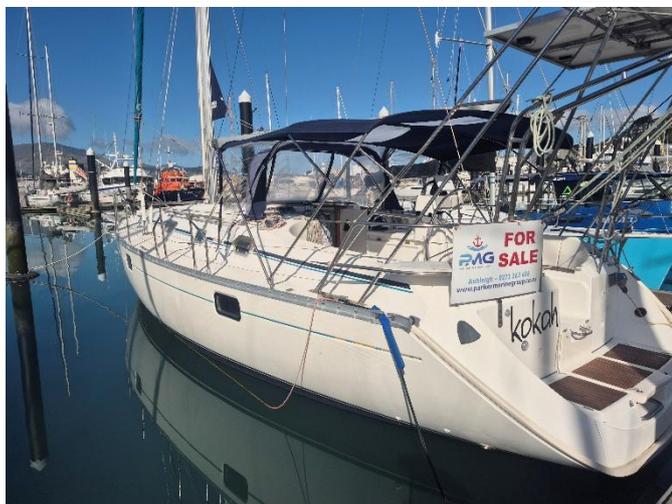
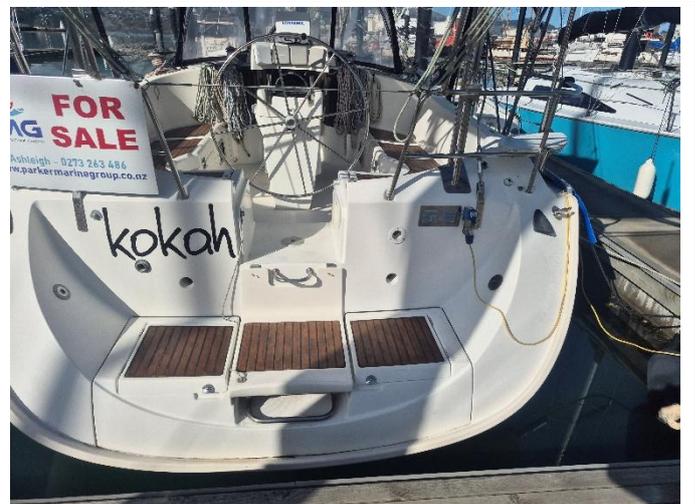
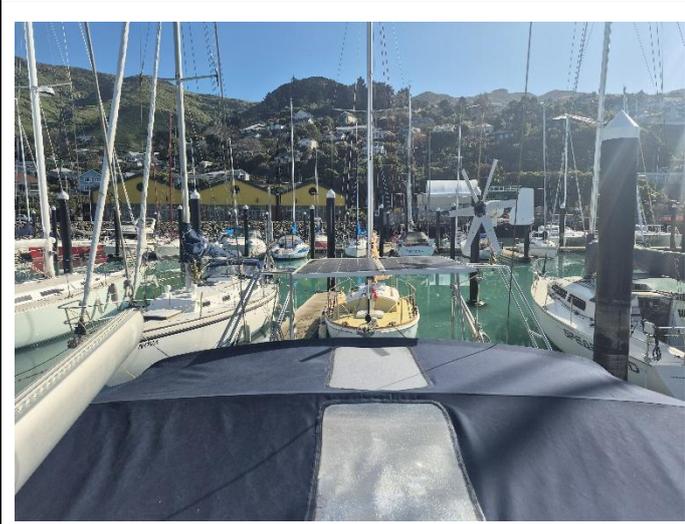
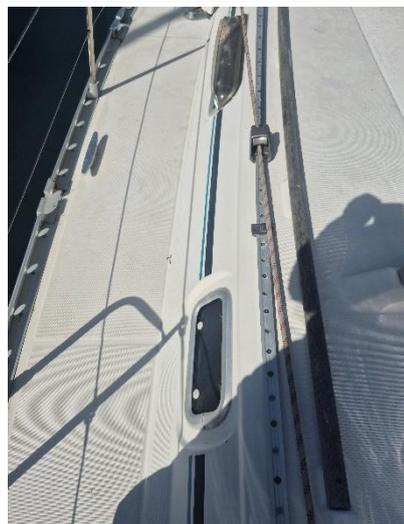
## 8. Decks & Superstructure

Top deck and superstructure in good condition with no signs of damage or deformation.

Good anti slip properties on deck.

Guard rails and stanchions seen in good condition and secure.

Bimini fitted and seen in good condition.

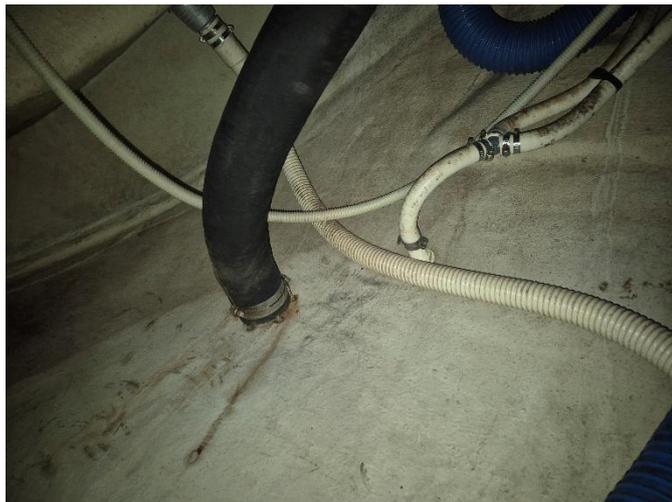
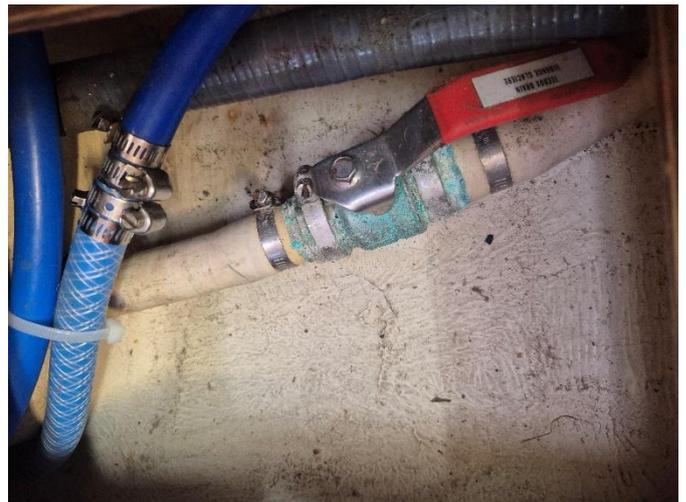
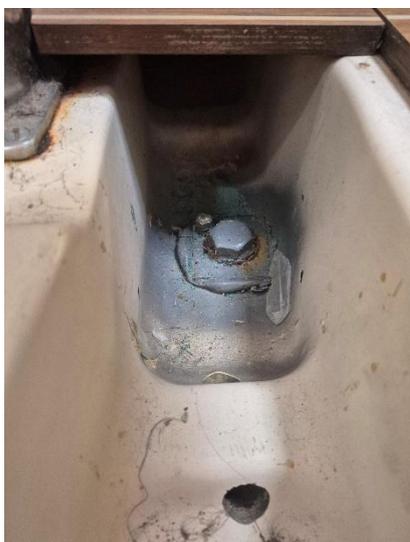
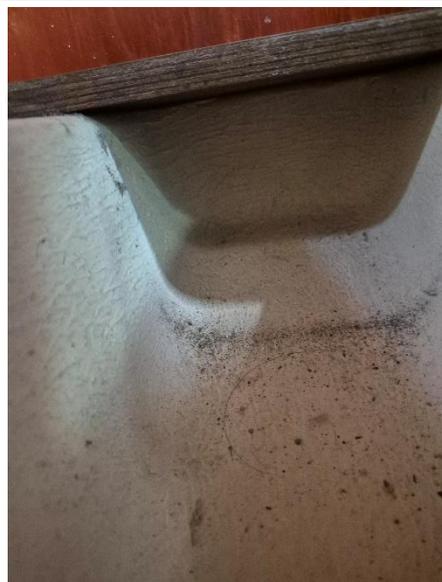
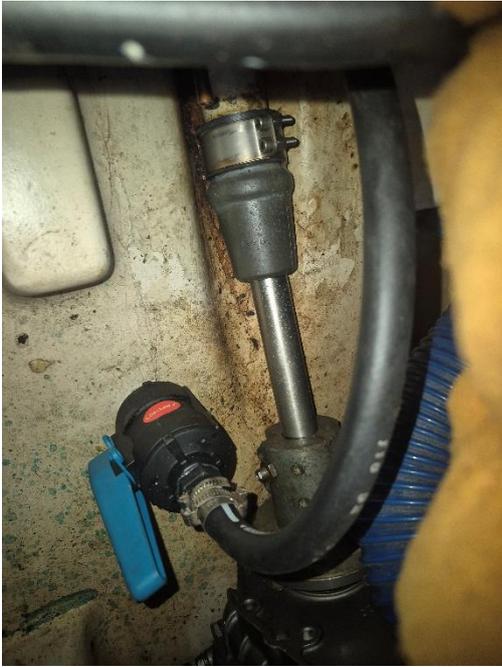
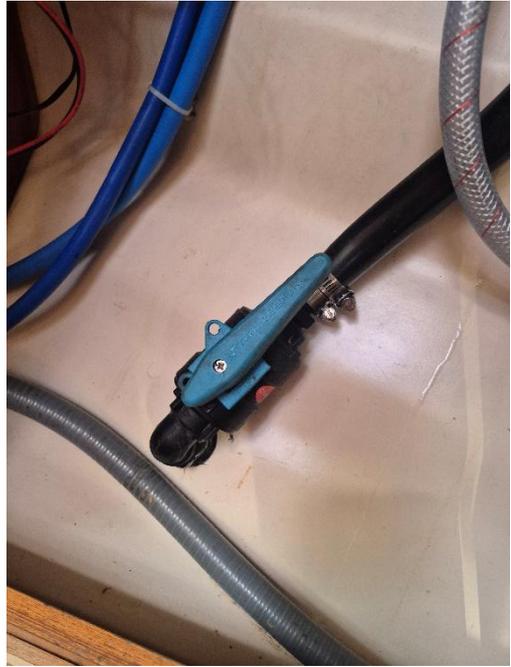
## 9. Internal Hull

Internal hull in good condition where seen with no signs of damage, deformation or rot to hull or structure. Bilges seen clean and dry.

Keel bolts seen and appear in good condition.

Sea cocks in good condition and operate with ease.

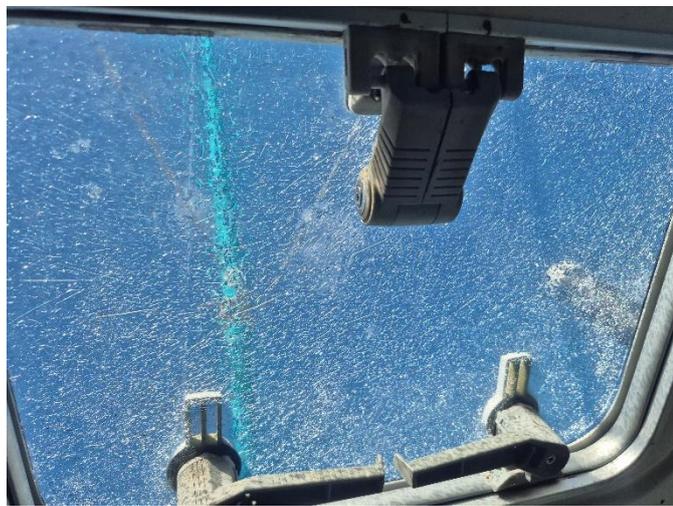
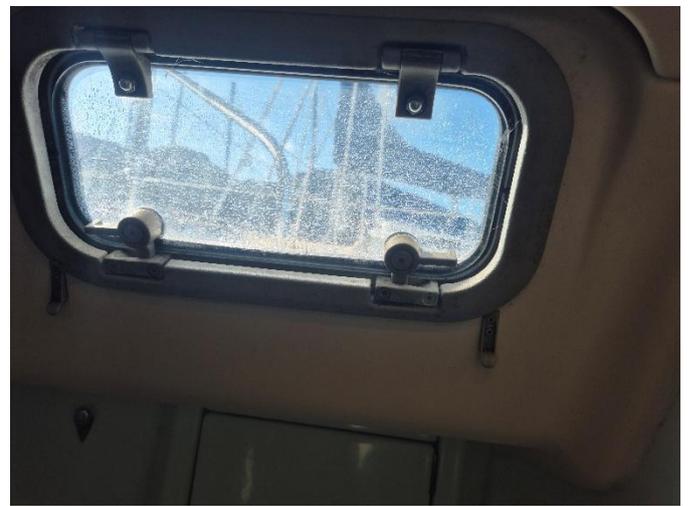
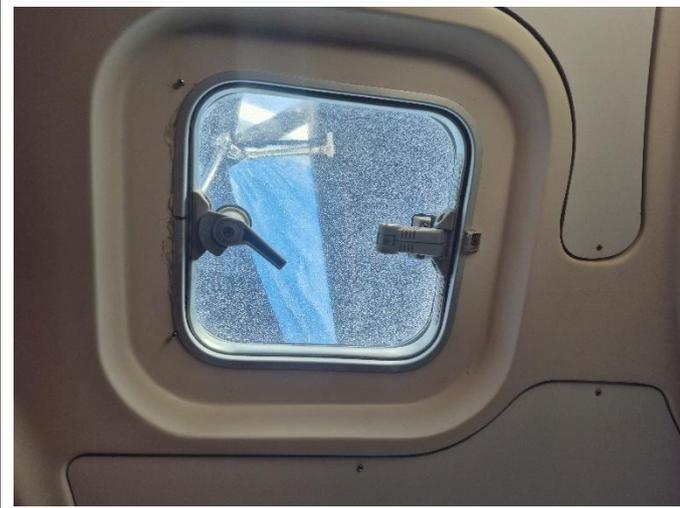
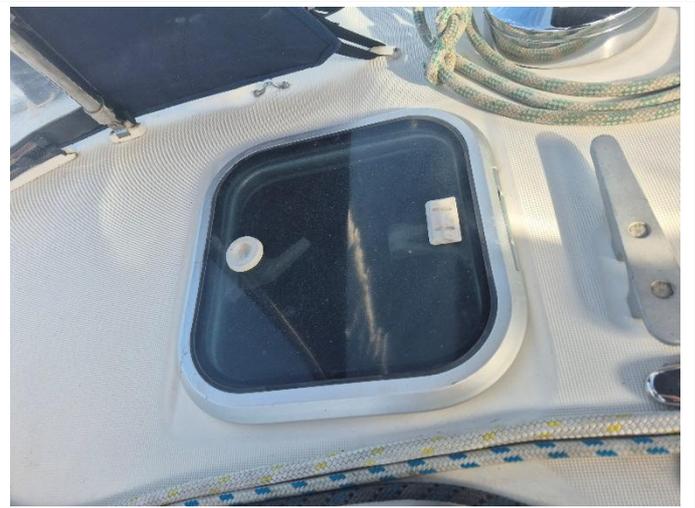
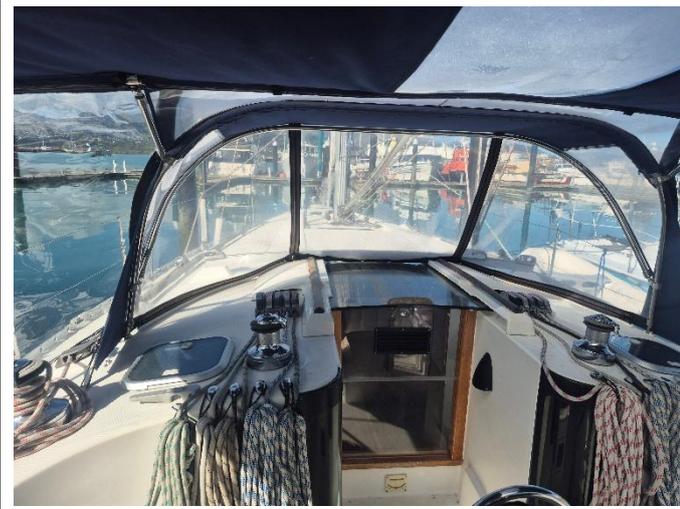
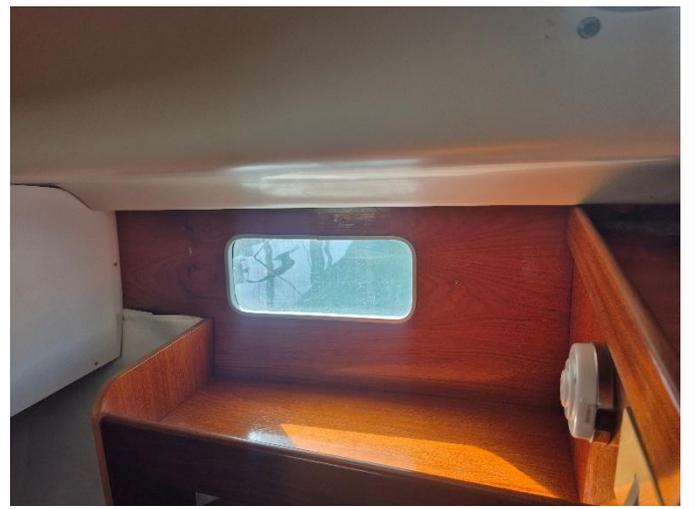
## 10. Doors, Hatches & Windows

All windows are in sound condition with no signs of leakage.

All hatches in good condition with no signs of leakage. All securing arrangements are working correctly.

**DEF C:** Some hatches and windows crazed.

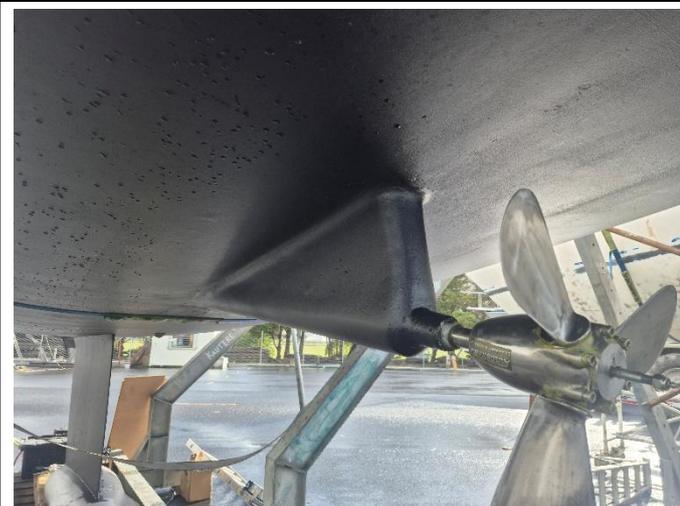
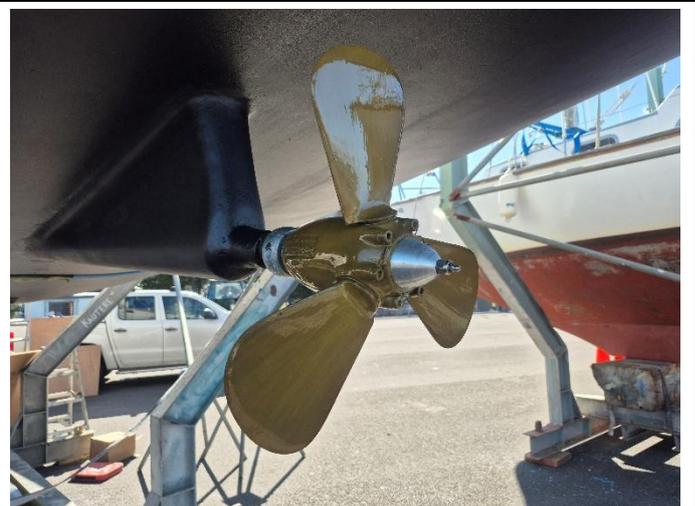
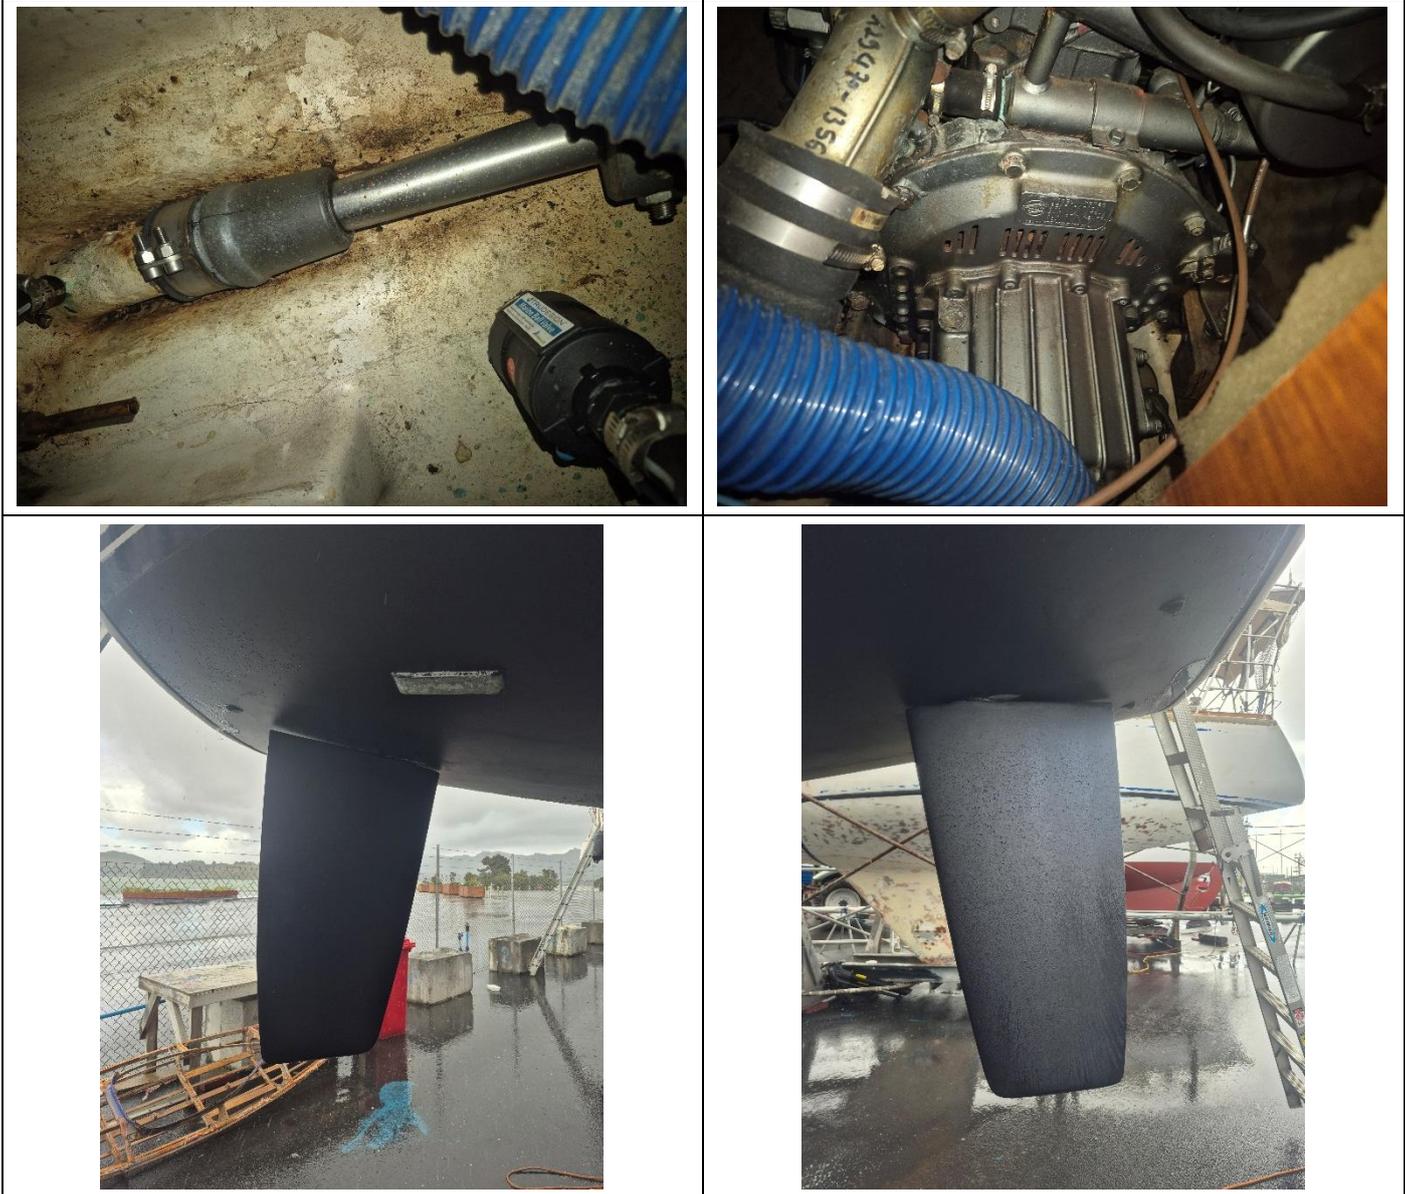
## 11. Drive Train & Steering

Shaft seen in good condition. No undue play in bearings.

Propeller seen in good condition and freshly coated in prop speed.

Rudder seen in good condition with no undue play observed in bearings.

Shaft seal seen in good condition with no signs of leakage.

Gearbox and coupling seen in good condition.

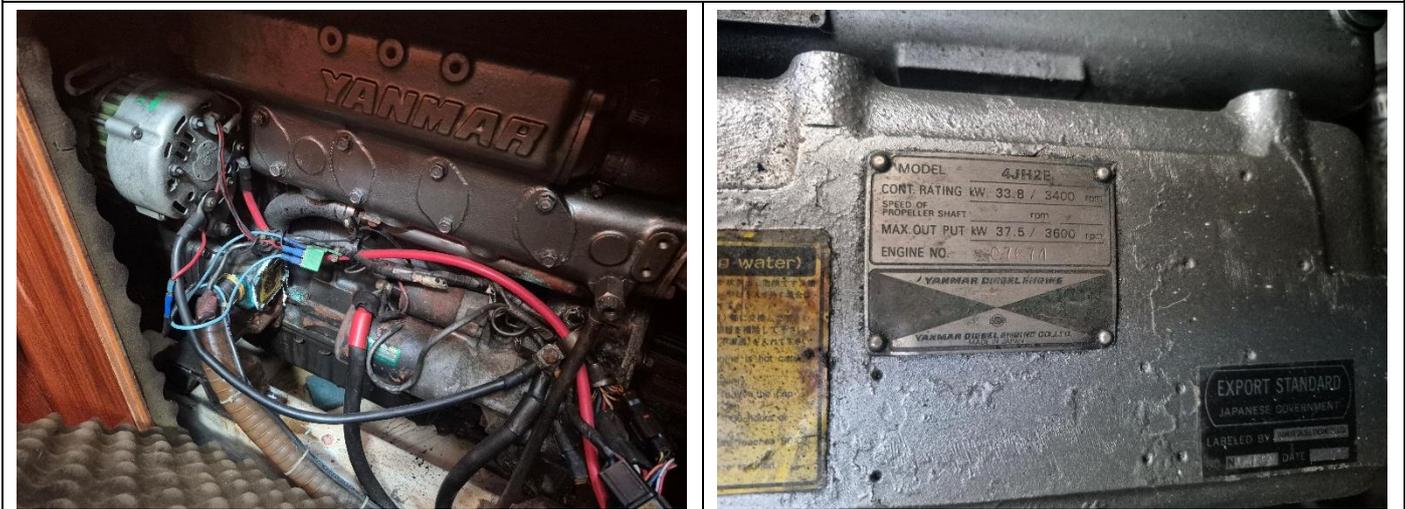
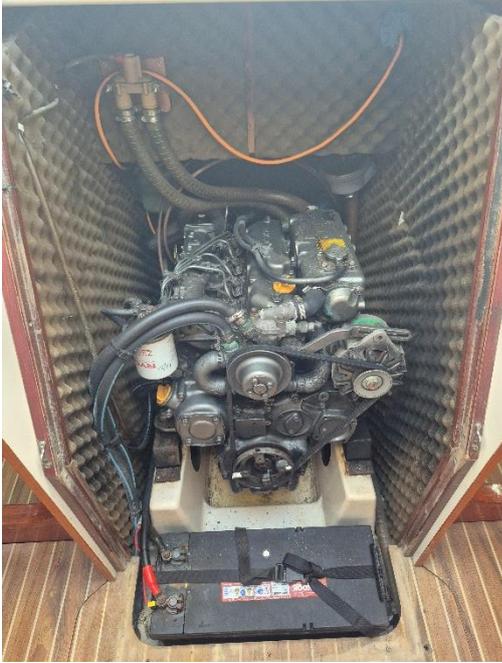
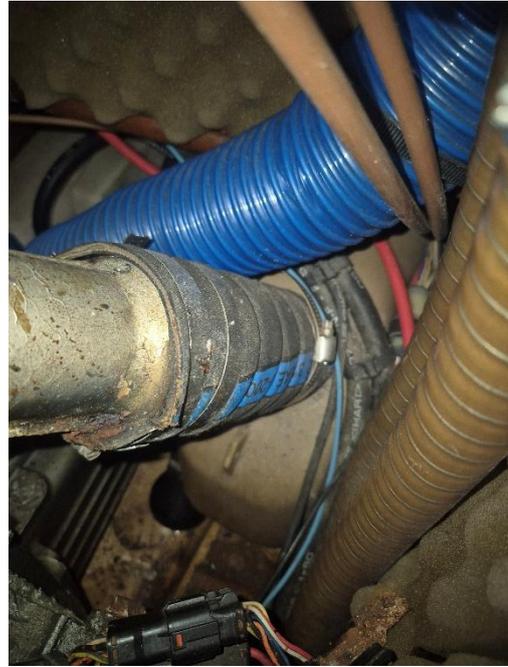
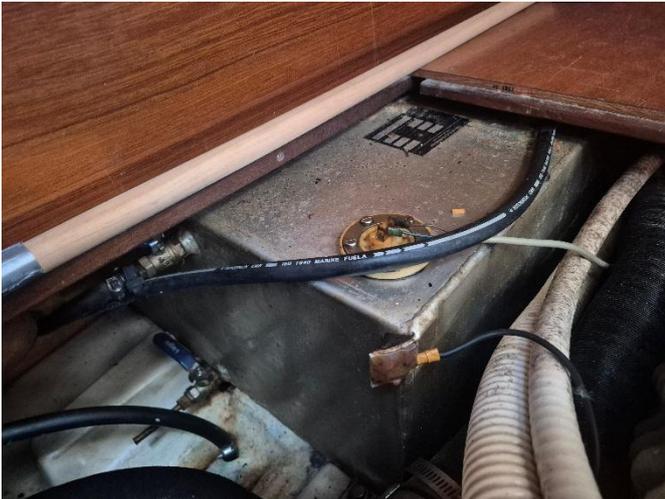
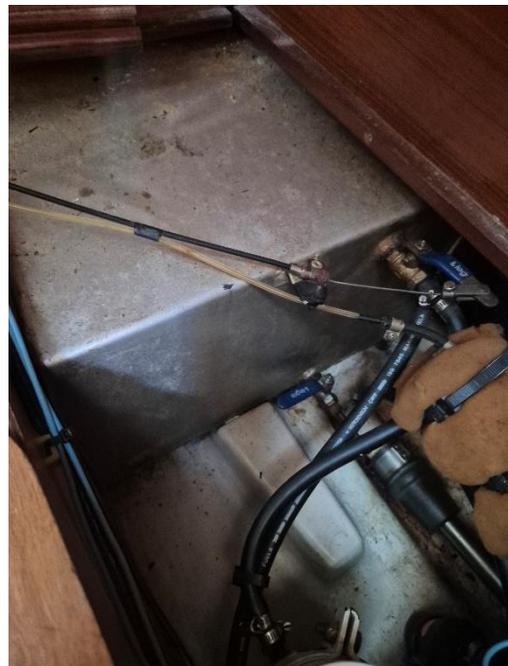
## 12.Engine & Associated Systems

Yanmar 4JH2E 48 hp fitted. Seen in good condition with 2477 hrs.

Engine box with acoustic linings seen in good condition.

Exhaust system appears in good order with no signs of leakage.

Fuel tanks (150l total) observed externally with no leakage evident. Fuel hoses and filters in good order.

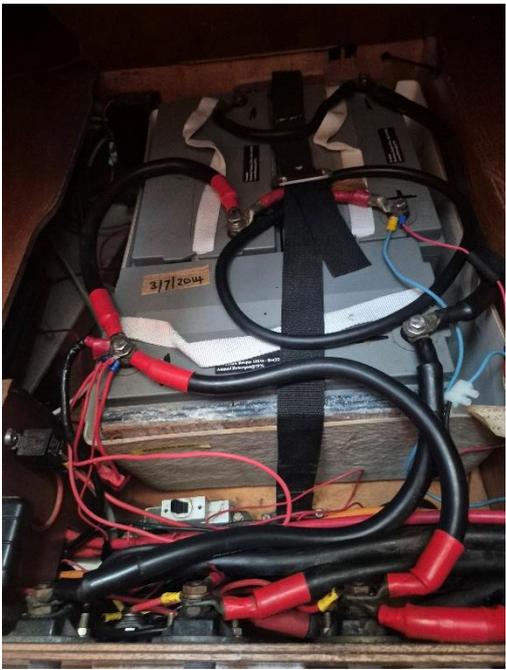
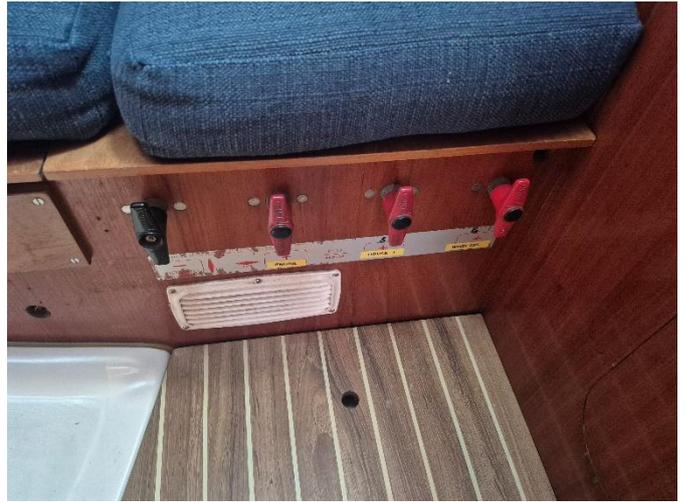
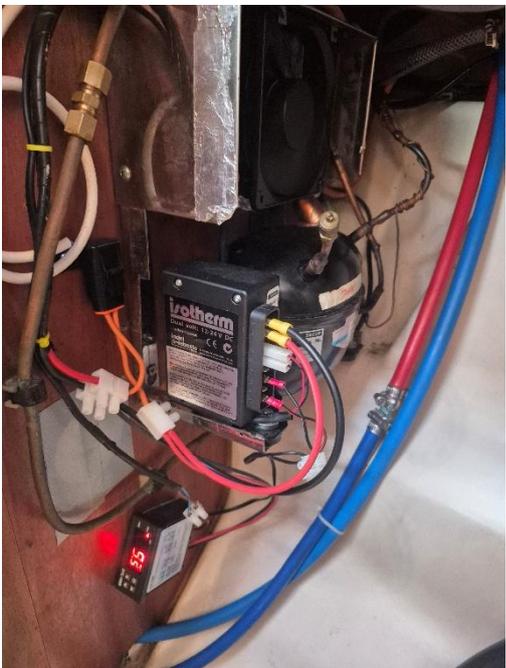
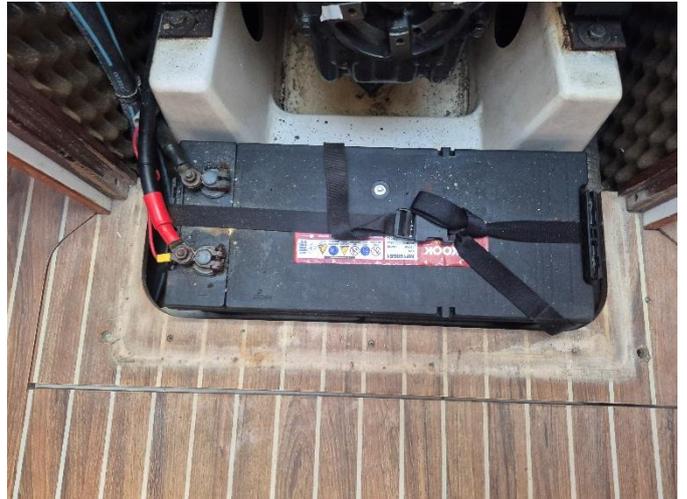
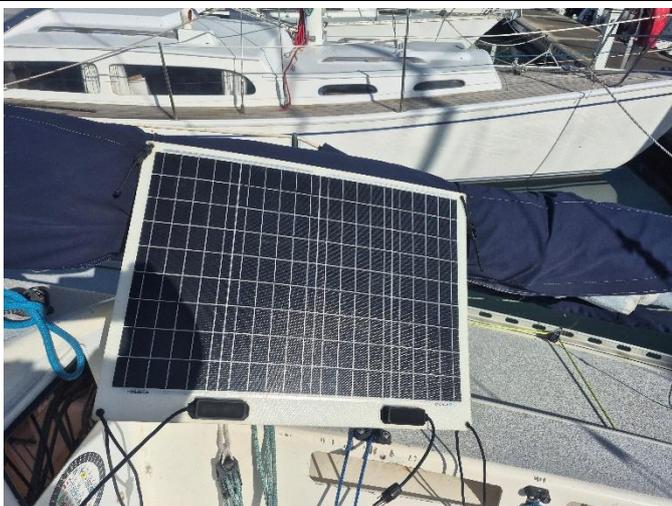
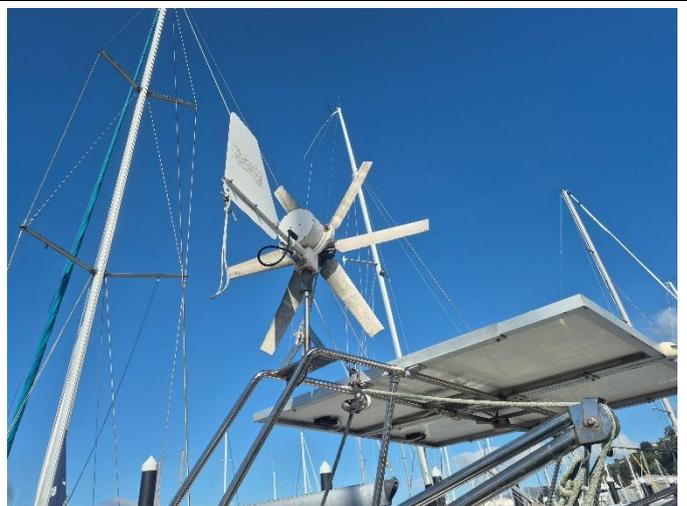
### 13. Electrical Systems

Electrical system seen in good order. Vessel in date for EWOFF. Expires 4/11/25

No damage to wiring observed where seen.

All breakers, switches and fuseboards seen in good order and properly labelled.

Batteries in good visual condition. Suitably housed and secured.

Wind generator installed, but no working at time of survey.

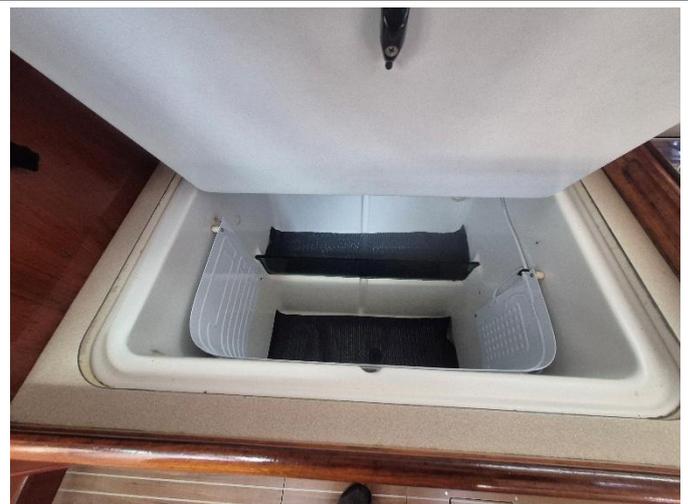
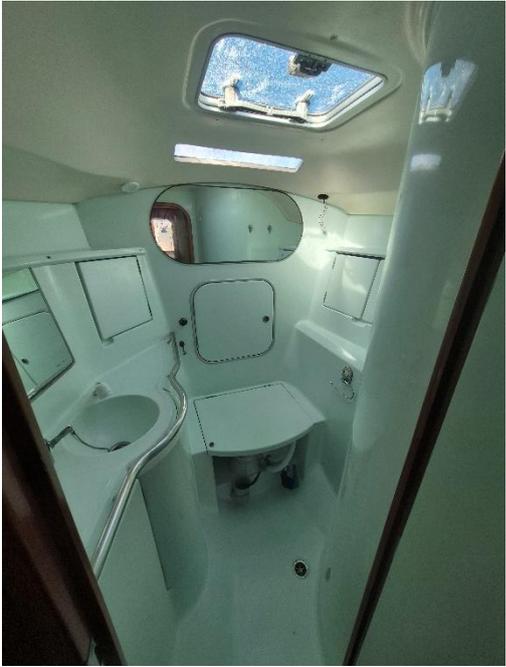
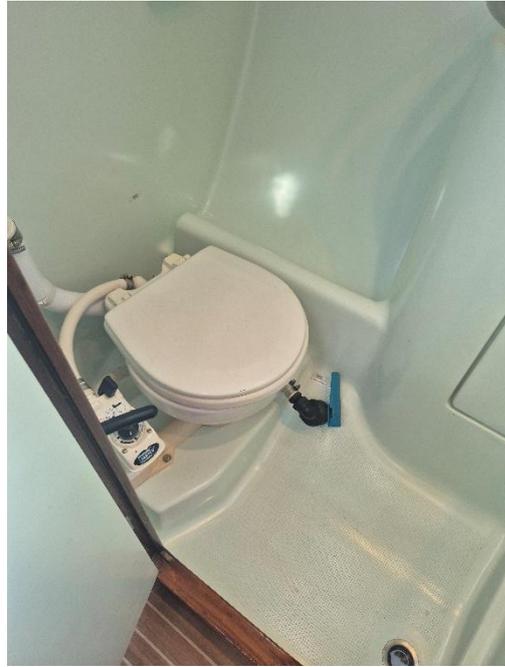
## 14. Galley, Bilge & Sanitary Systems

Small kitchenette appears in good condition. Cooker gimbaled.

**DEF B:** System has Gas Safety Certificate expired 2023, however system appears in good condition.

Fresh water tanks (530l in total) seen externally in good condition.

**DEF C** Hot water system needs new thermostat.

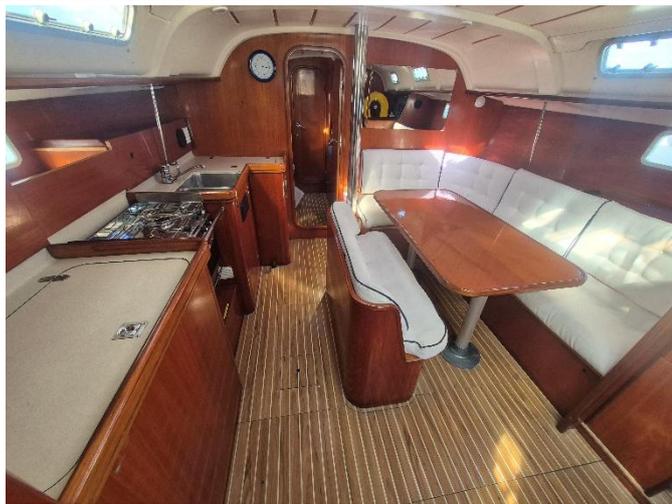
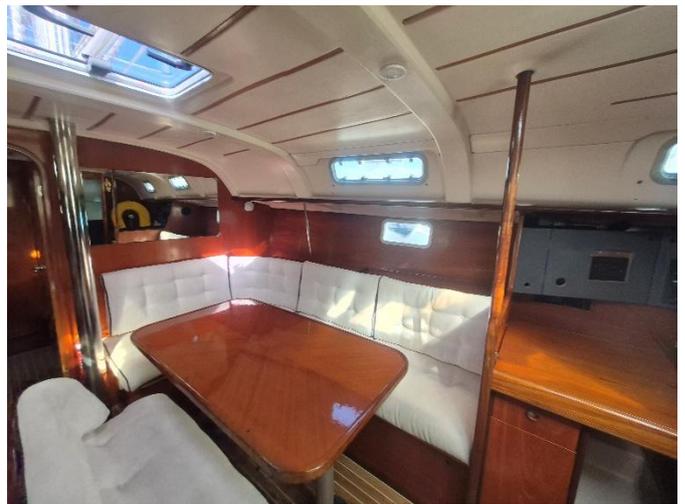
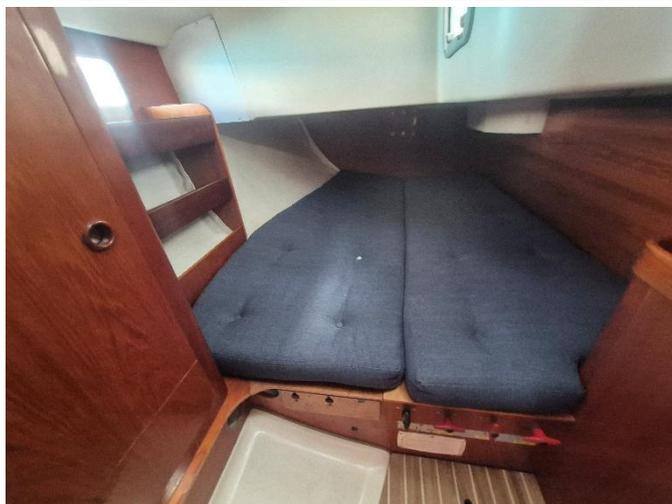
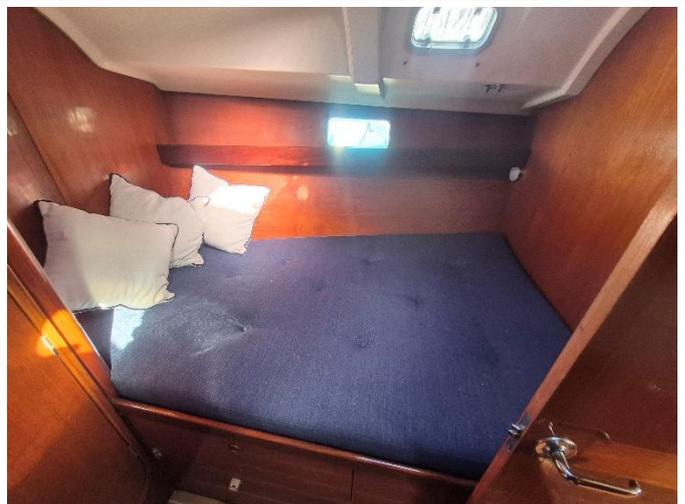
## 15.Accommodation

Bunk spaces in good condition. No signs of mould or dampness.

Mess square in clean condition, upholstery in good condition. No signs of damp or mould.

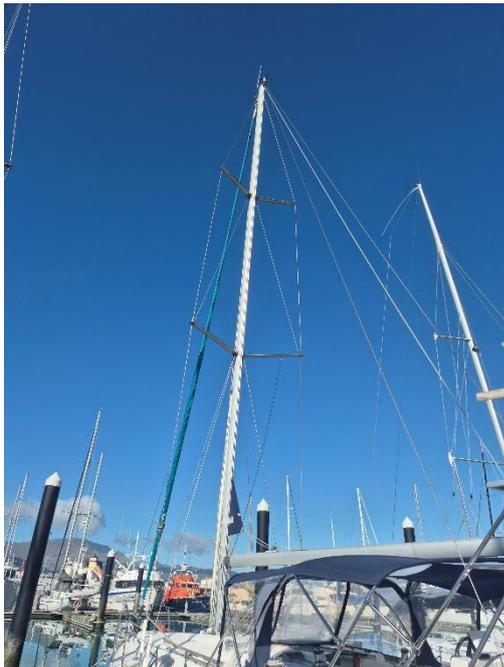
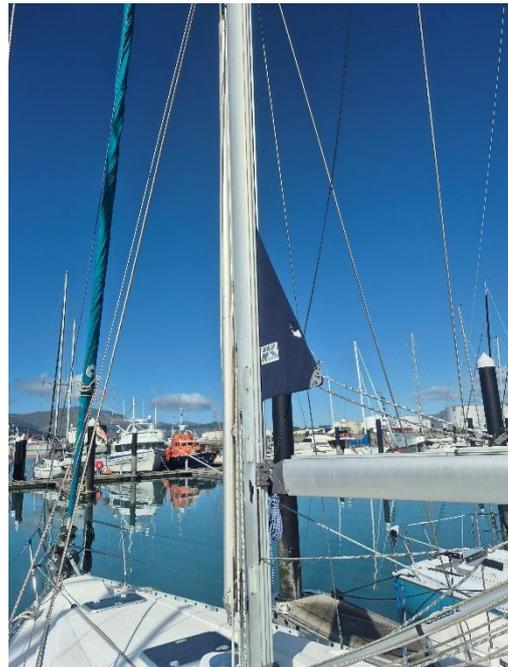
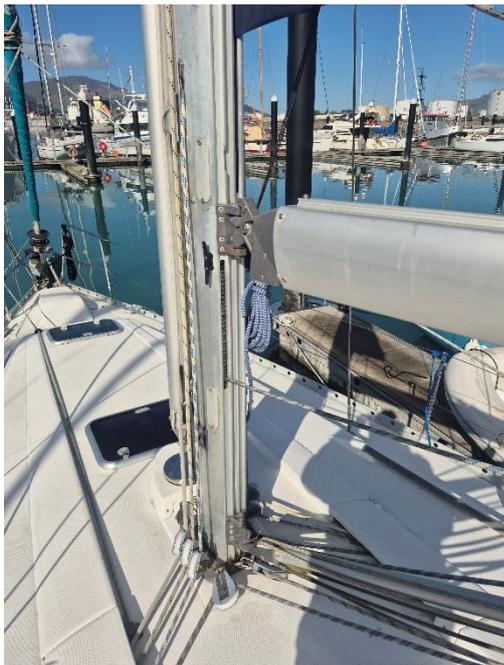
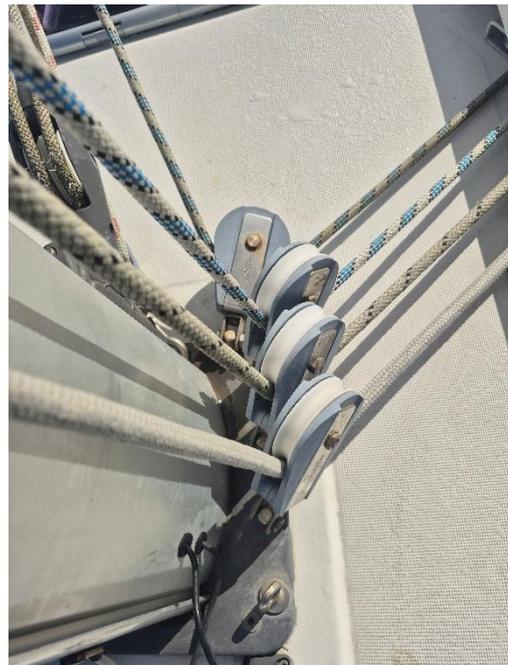
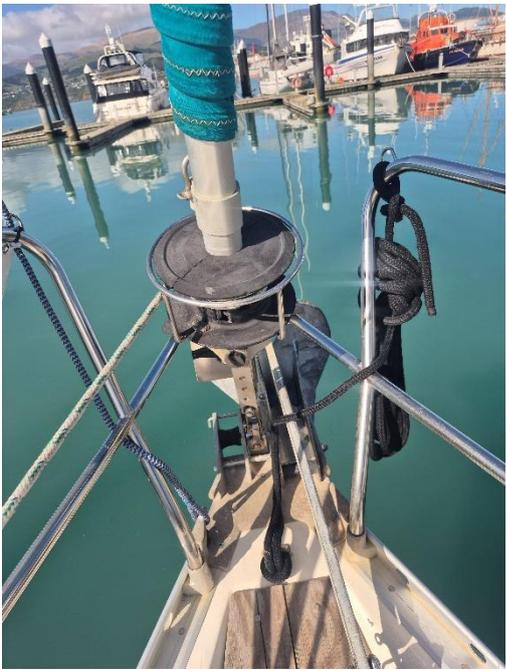
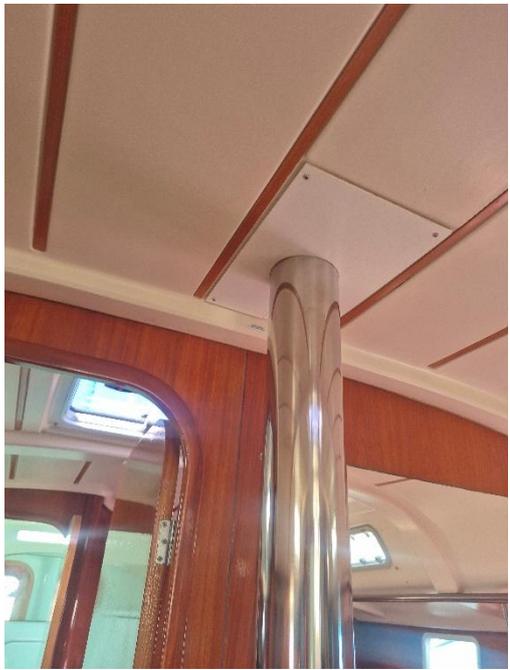
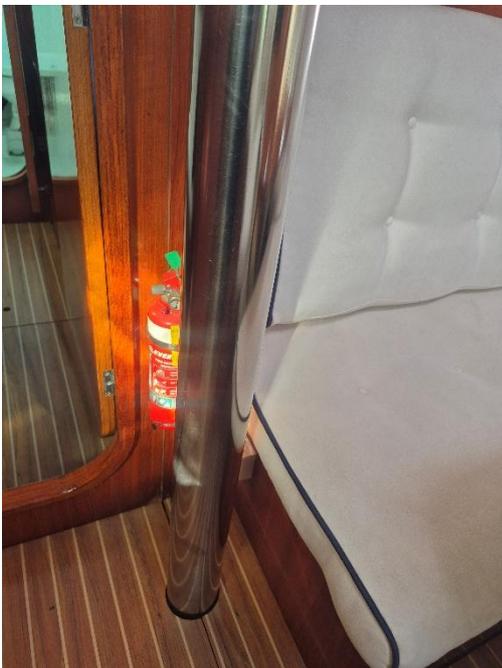
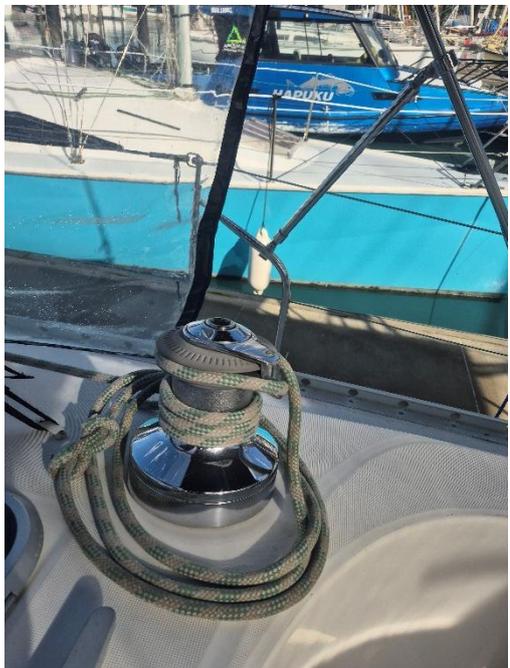
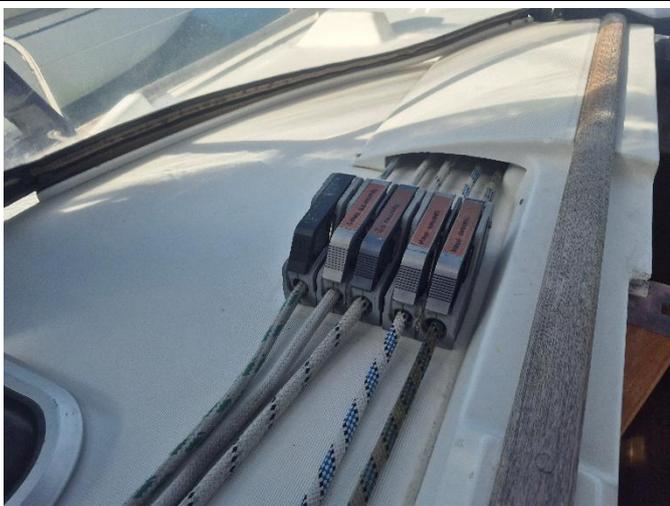
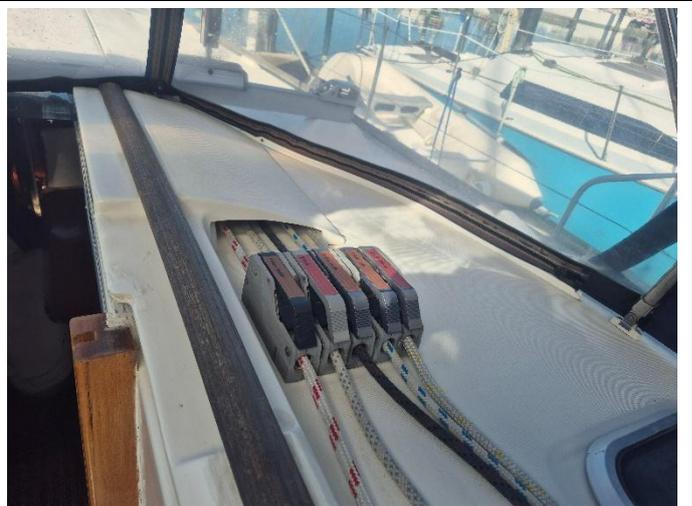
## 16.Mast, Sails & Rigging

Vessel underwent rigging survey in Aug 2025. All running and standing rigging seen in good condition. Mast, boom and spars appear in good order from deck level. Mast step observed in good condition.

Chain plates seen in good condition.

Mast securing arrangements appear in good order.

All winches appear in fair condition.

All blocks, cleats and chain plates appear in fair condition.

Vessel equipped with main sail (2019), headsail (2017) on furler, storm jib, 1 x spinnaker, 1 x spare head sail (unknown age). Main and head sail seen in good condition.

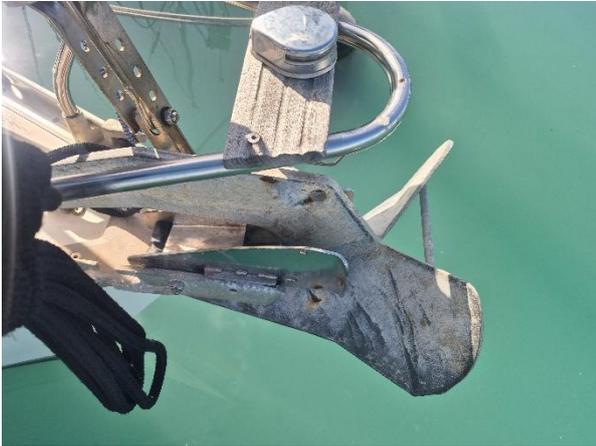
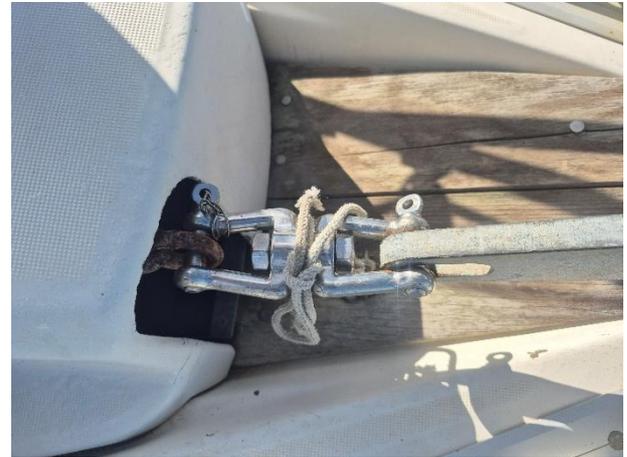
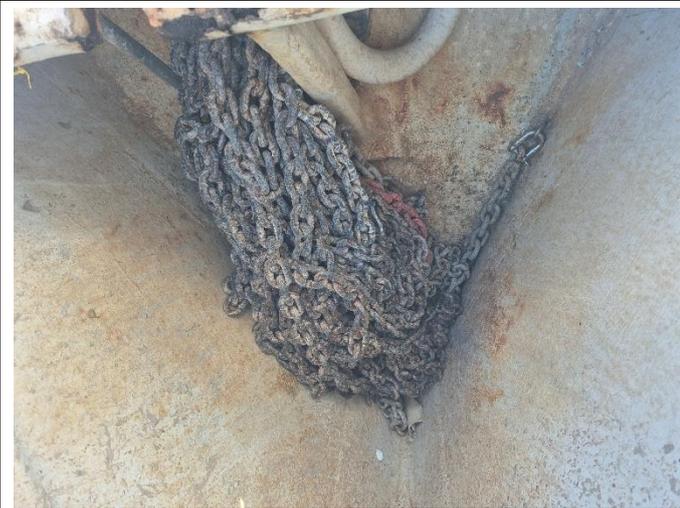
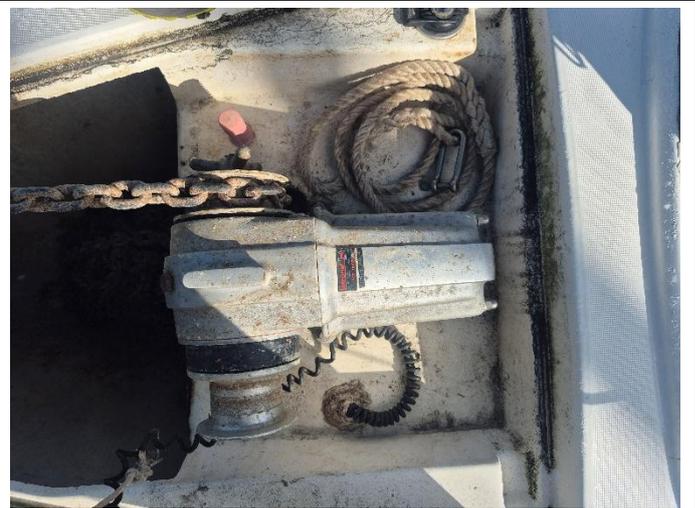
## 17. Anchoring Equipment

Fairlead in good condition.

Plough anchor carried and seen in good condition.

Chain carried, seen in good condition.

Windlass tested from local controls and working correctly.
