## PRE-PURCHASE CONDITION SURVEY REPORT

*Kokah*

Date	11/09/25
Report No.	025/PSS/006

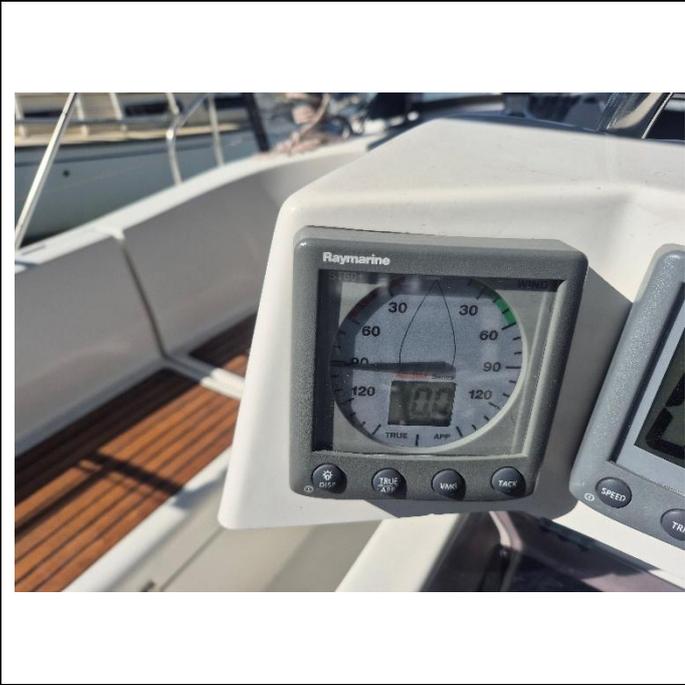
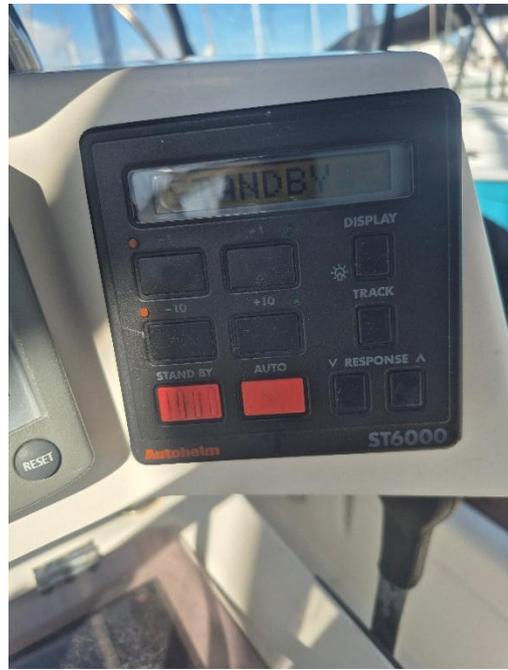
## 18. Navigation & Communication Equipment

1 x VHF and 1 x handheld VHF carried. Working correctly.

Vessel fitted with GPS plotter, AIS transceiver, wind and depth displays. All working correctly.

Navigation lights tested and working correctly.

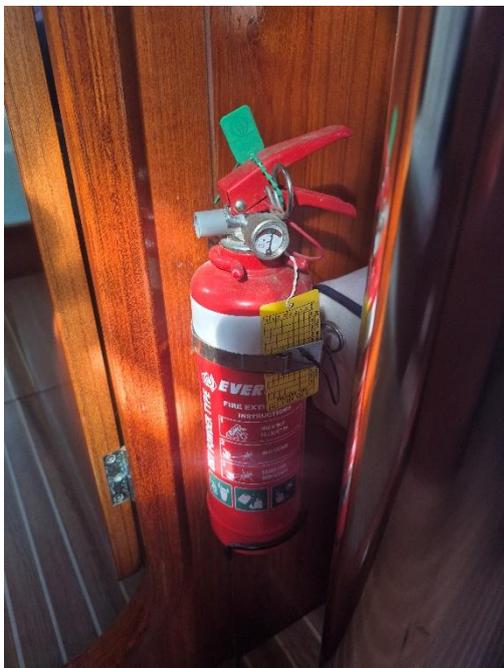
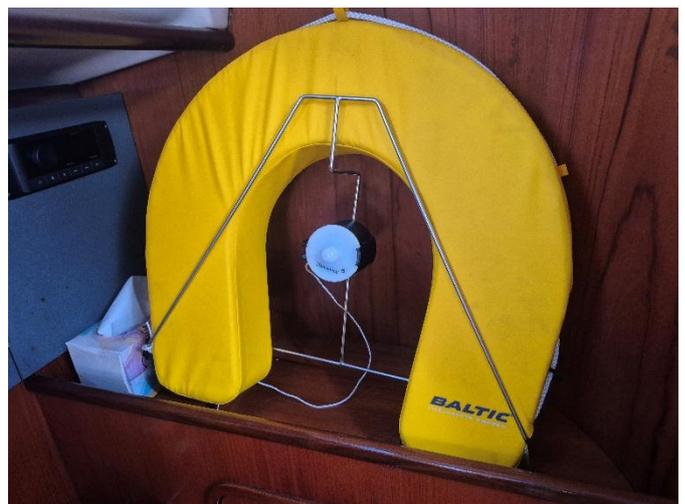
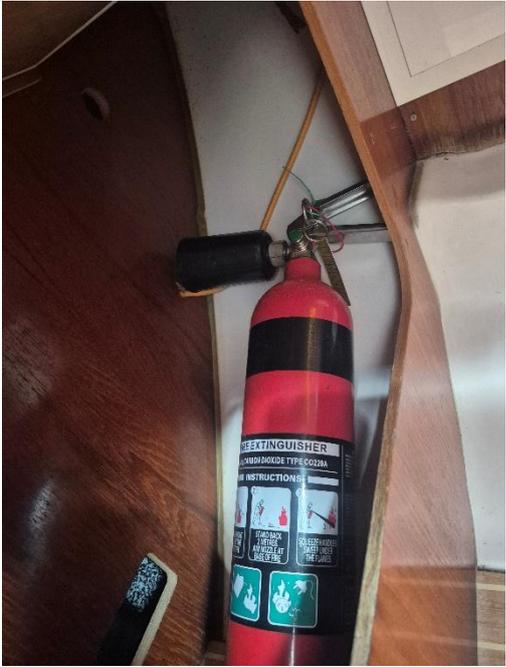
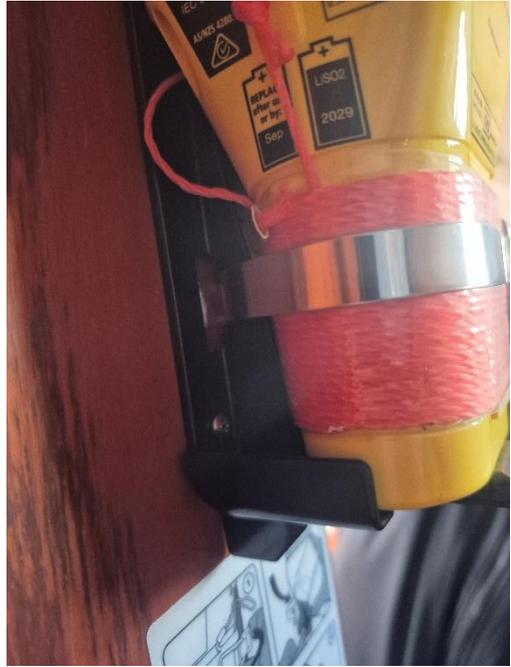
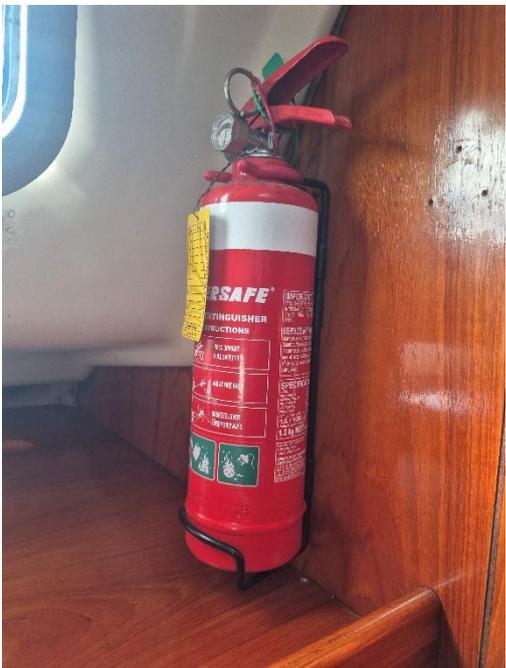
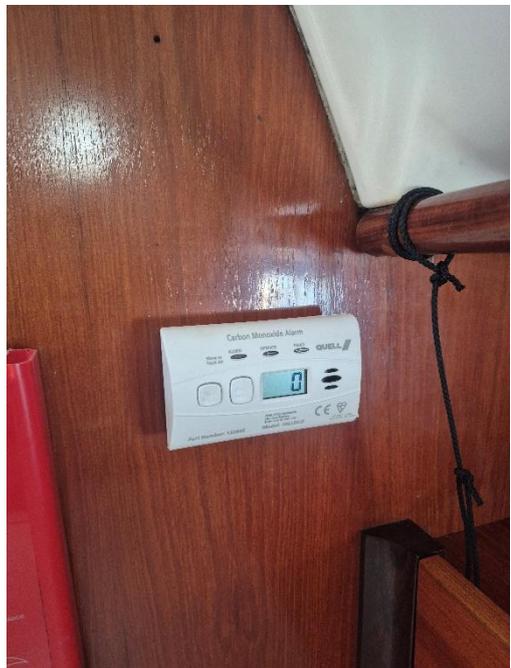
## 19. Safety & Miscellaneous Equipment

Carbon Monoxide detector installed and in working order.

EPIRB carried with battery in date (Sep 2029)

Life jackets carried, seen in good condition.

3 x fire extinguisher carried, all fully pressurised.

Tender carried and seen in good condition. Tender davits seen in good condition.
