PRE-PURCHASE CONDITION SURVEY REPORT

Concept

Date	30/03/25
Report No.	025/PSS/003

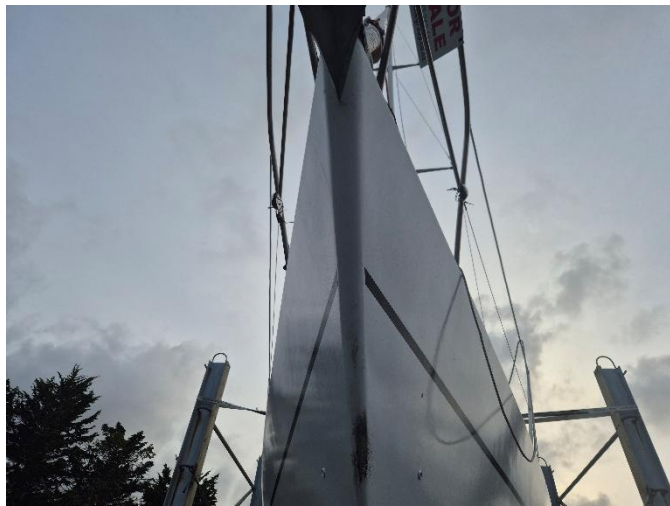
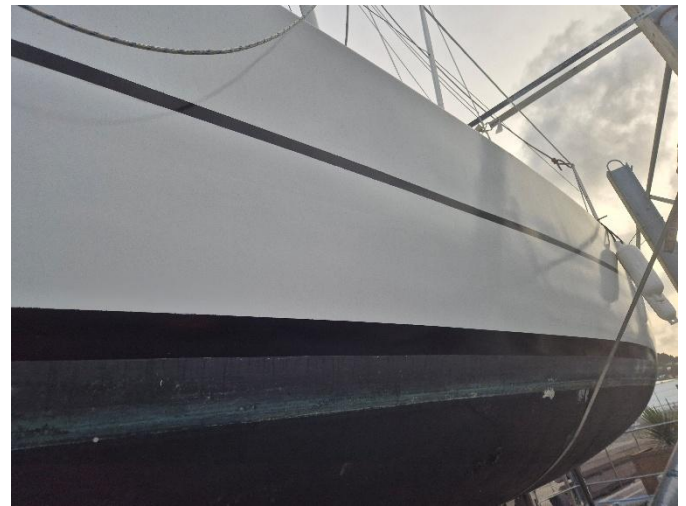
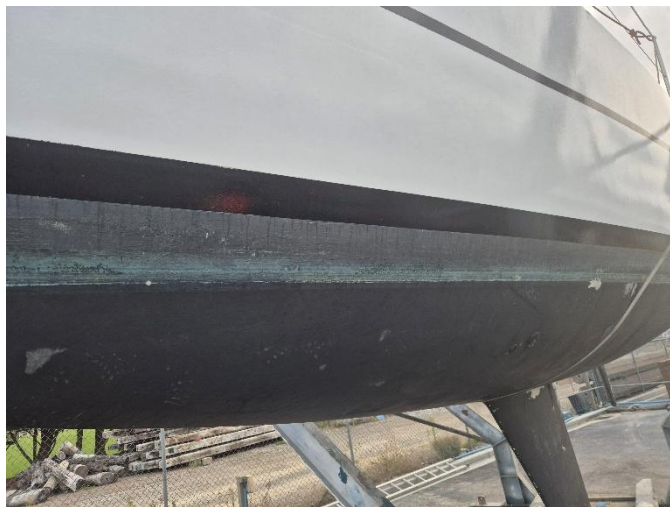
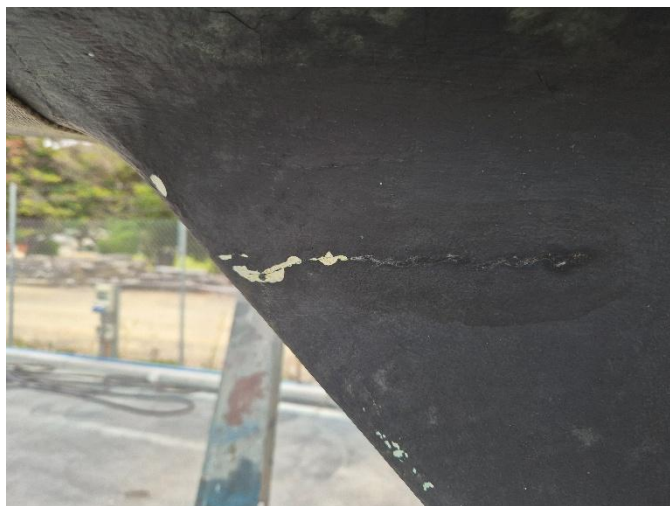
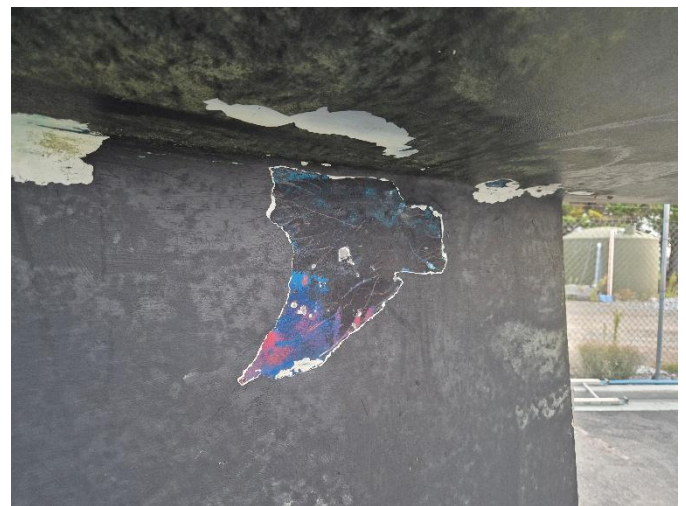
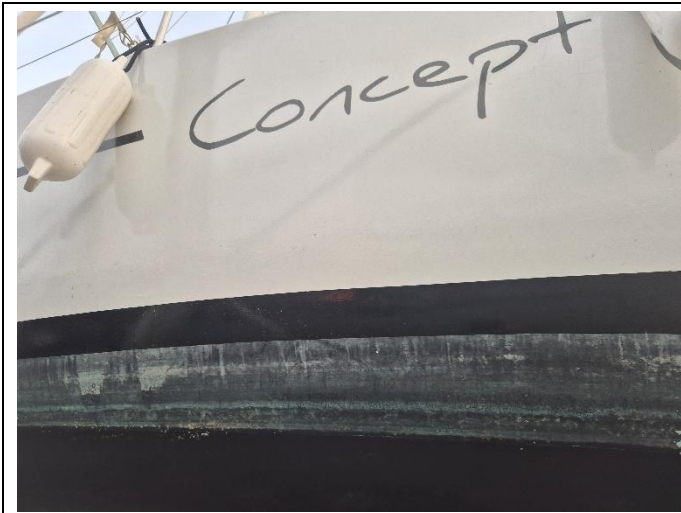
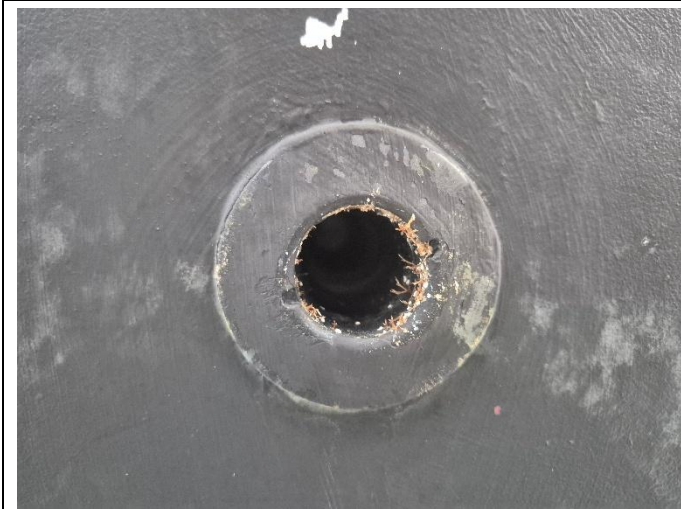
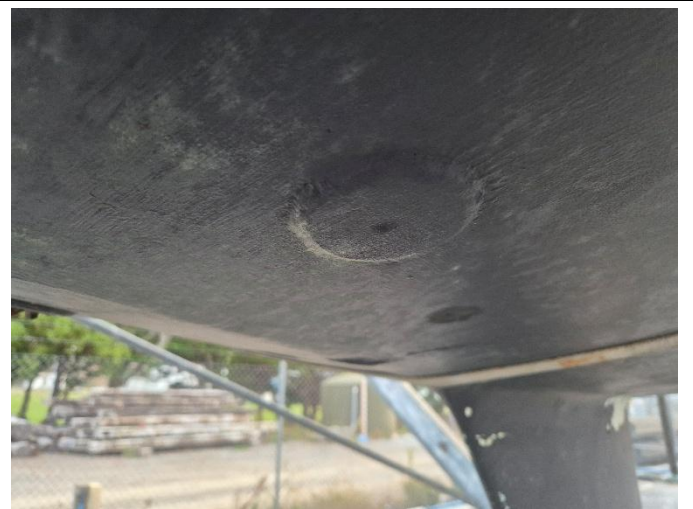
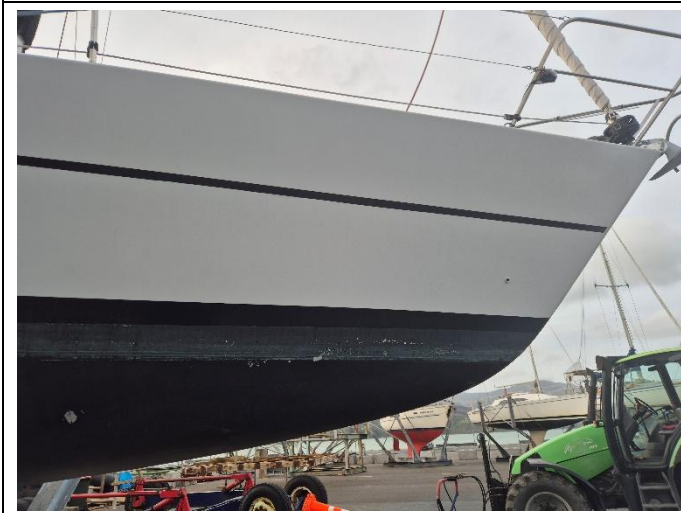
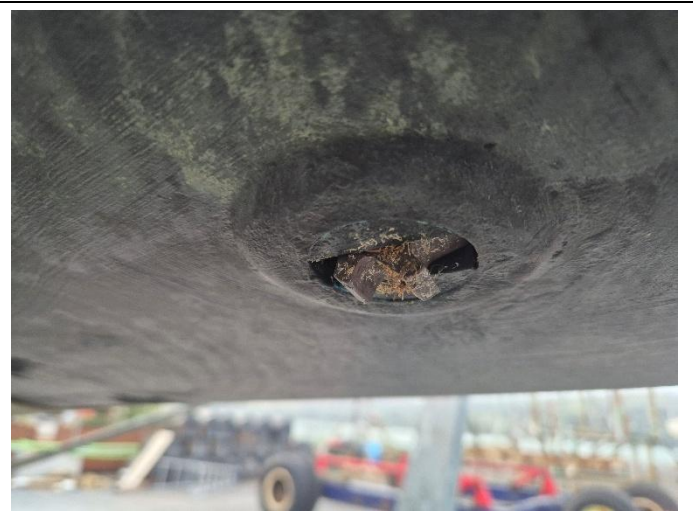
7. Hull, Coatings & Submerged Fittings

Hull is glass over triple diagonal Kauri. No major signs of damage, deformation or rot.

DEF C: Fin keel has crack in gel coat. At point of highest stress concentration (upper leading edge). Usually an indication of keel bolts not quite tight enough. Recommend repair before it gets worse.

Inlets and discharges in good condition and free from biofouling. Suitable backflow protection in place.

Echo sounder transducer appear in sound condition.

Sum log spinning correctly.

DEF B: Anti-foul peeling in areas, indication that it was applied in damp conditions.

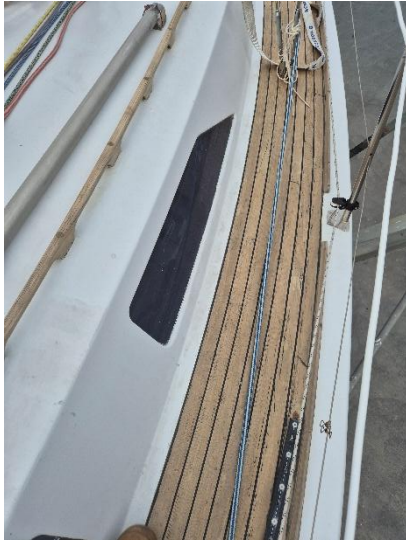
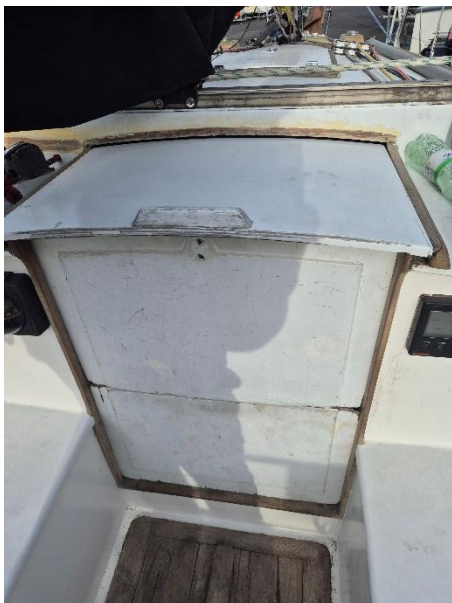
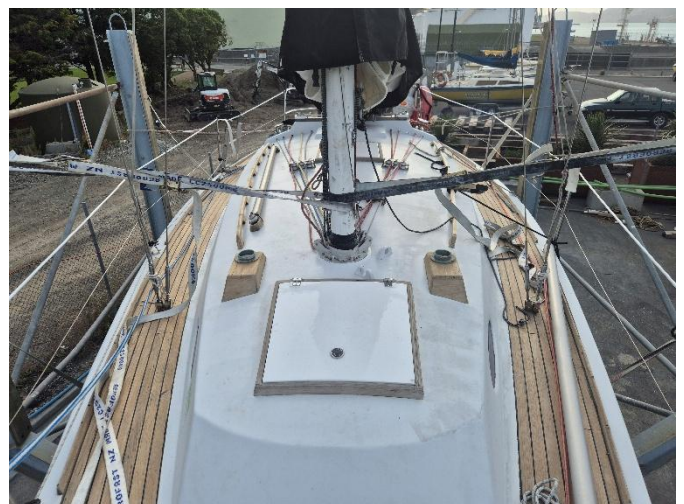
8. Decks & Superstructure

Deck appears in structural sound condition.

Top deck and superstructure in good condition with no signs of damage, deformation or corrosion.

Guard rails appear in good condition, no damage to stanchions.

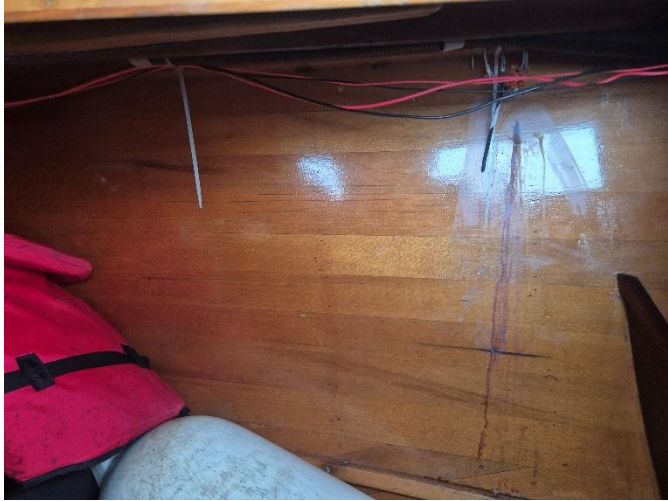
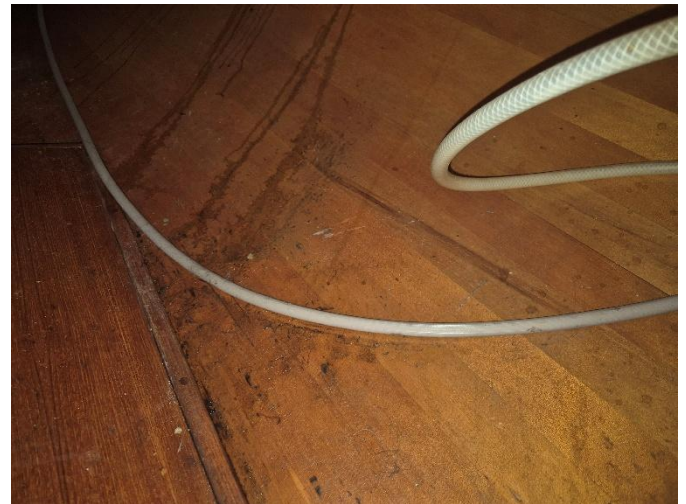
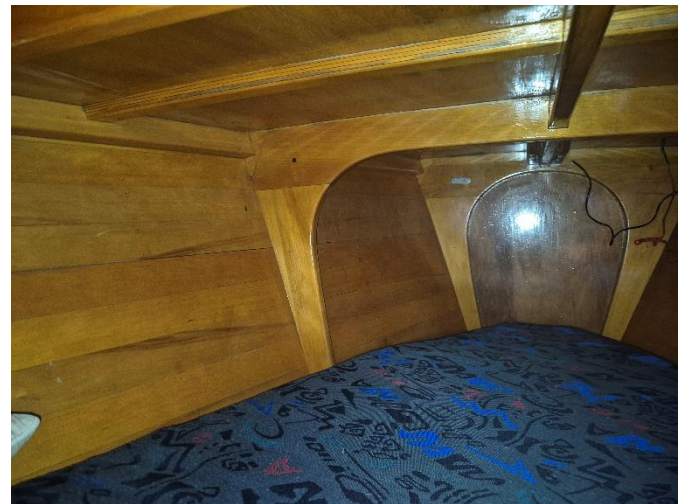
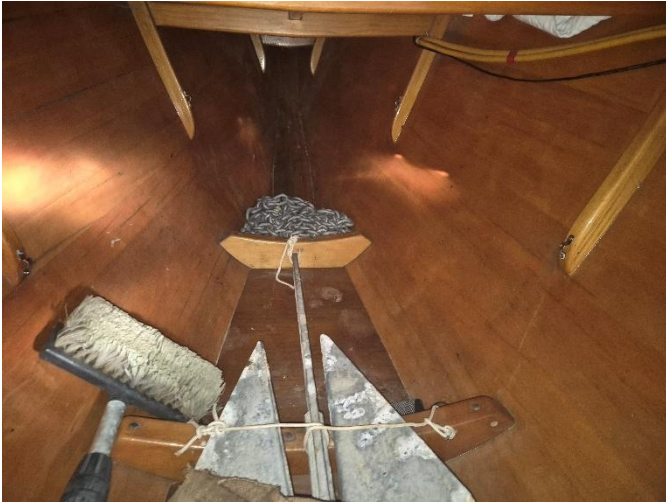
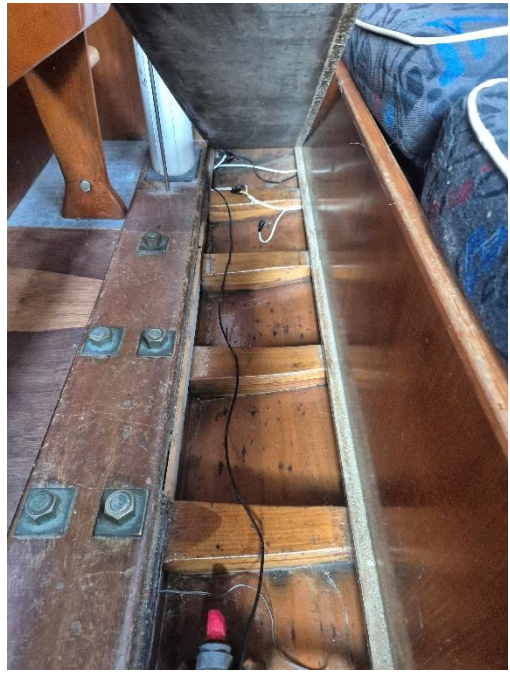
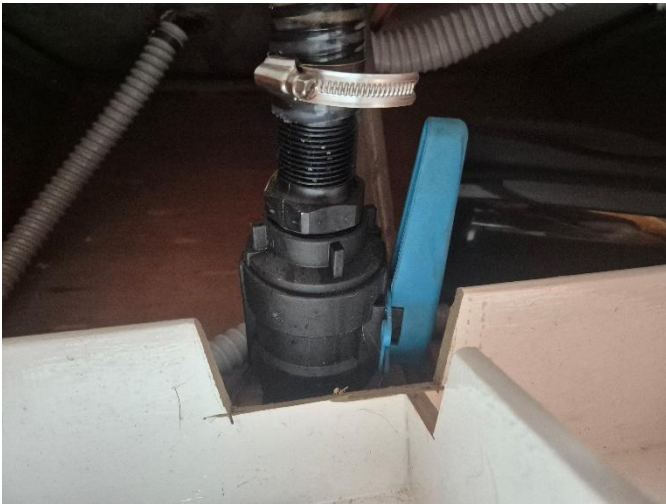
9. Internal Hull

Internal hull in good condition where seen with no signs of damage, deformation or rot.

Bilges seen clean and dry.

Keel bolts seen and appear in good condition.

Sea cocks in good condition and operate with ease.

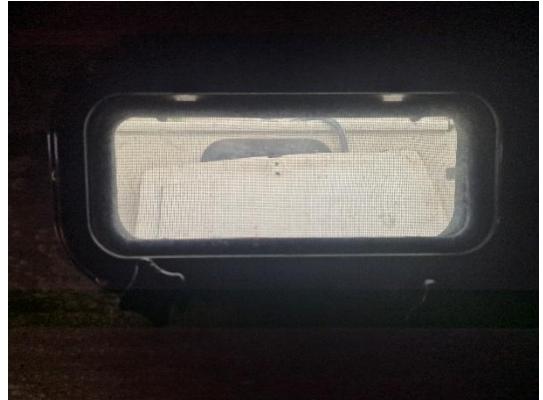
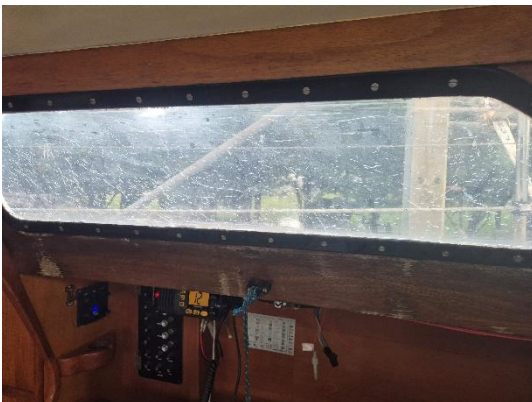
10. Doors, Hatches & Windows

Companionway in good condition.

DEF C: All windows are in sound condition with no signs of leakage, however crazed.

All hatches in good condition with no signs of leakage. All securing arrangements are working correctly.

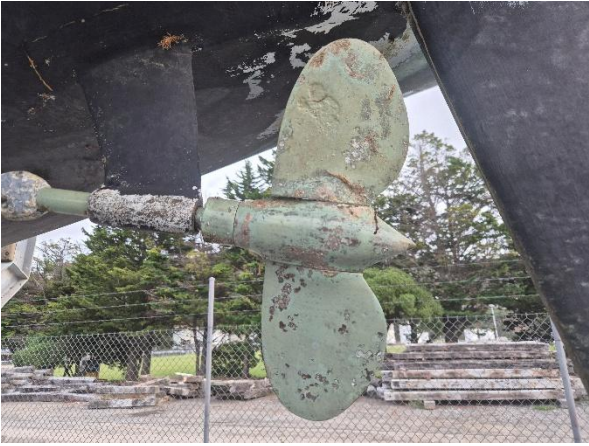
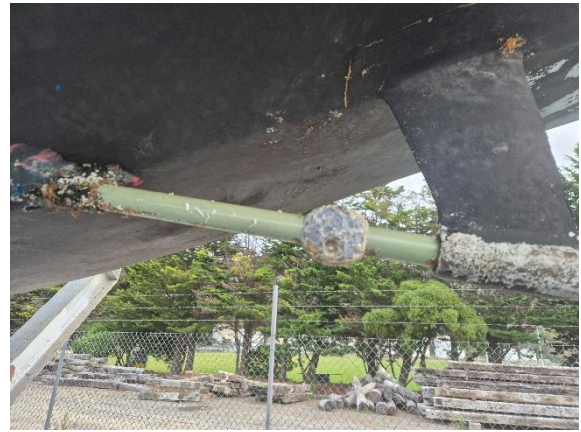
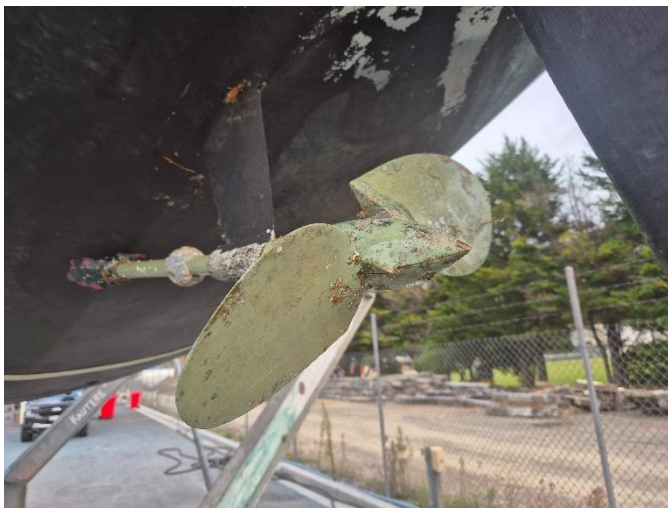
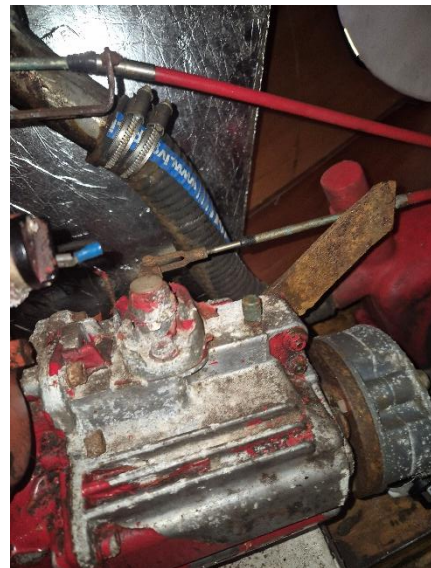
11. Drive Train & Steering

Shaft seen in suitable condition. No undue play in bearings.

Propeller seen in fair condition. Coated in propspeed.

Rudder seen in good condition with no undue play observed in bearings.

Shaft seal see in good condition with no signs of leakage.

Gearbox and coupling seen in good condition.

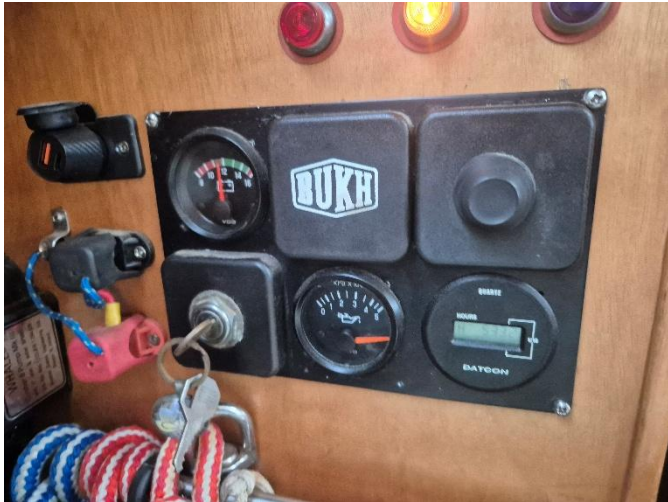
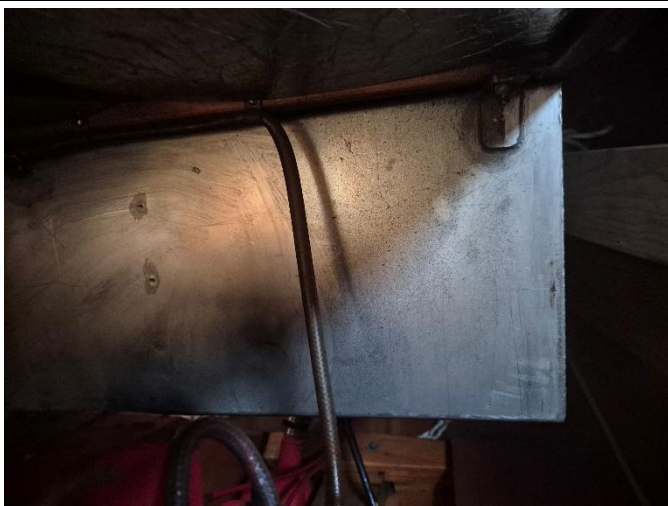
12.Engine & Associated Systems

Bukh DC20 20HP engine fitted. No service records available.

Engine appears in good order with no signs of oil leakage and mounts in good condition.

DEF C: engine hrs clock reads 533 hrs, however this is most likely broken as this a low number of hours for an engine of this age.

Exhaust system appears in good order with no signs of leakage.

Fuel tank (90l) observed externally with no leakage evident.

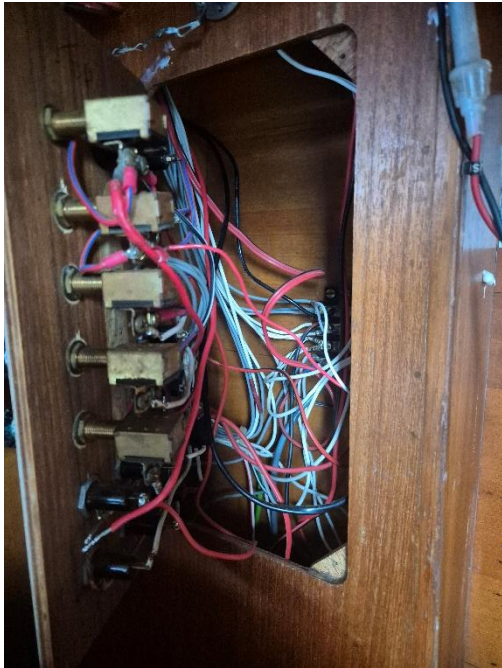
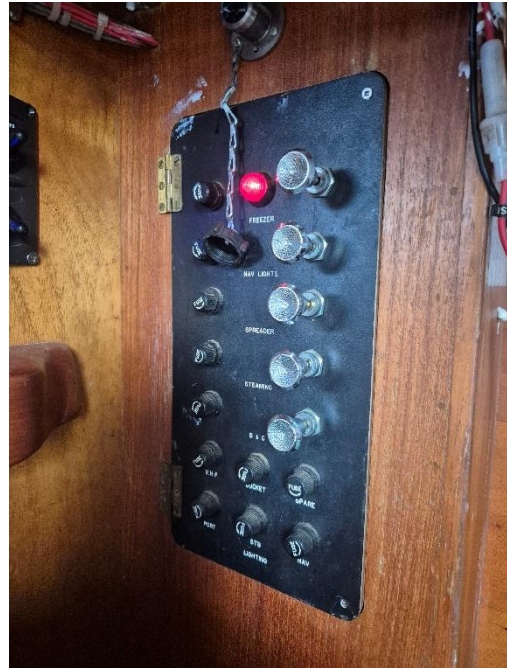
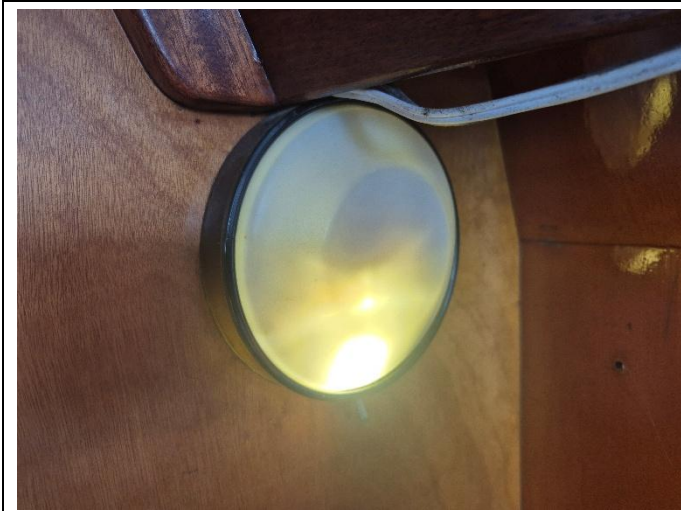
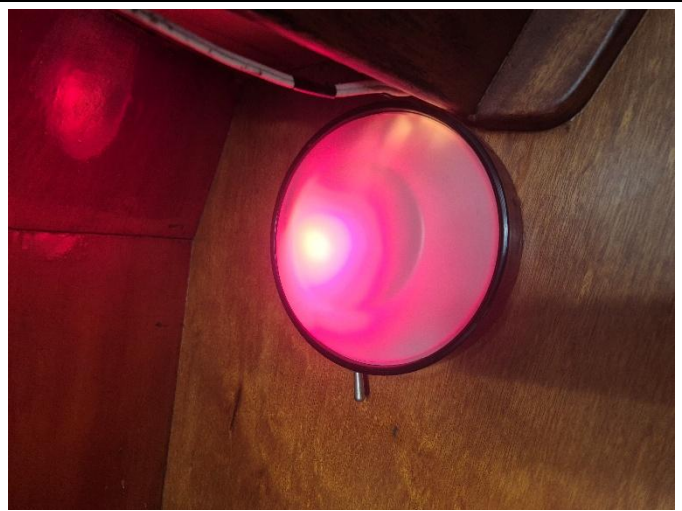
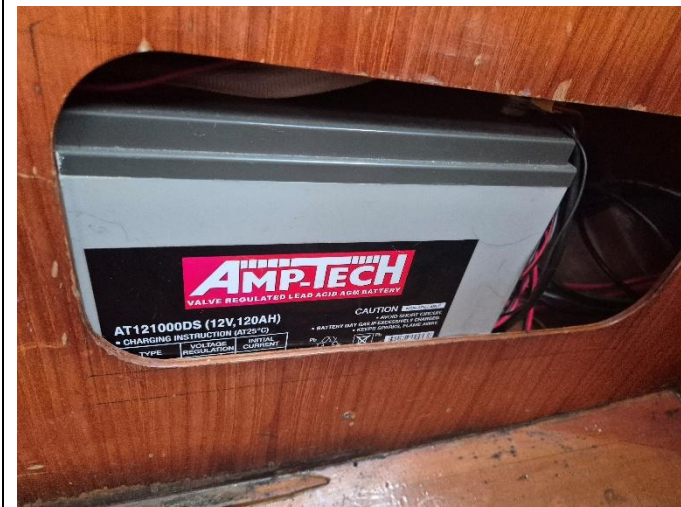
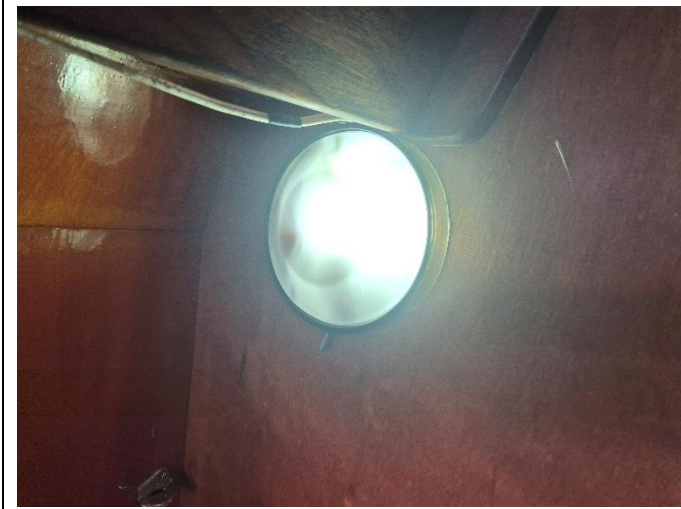
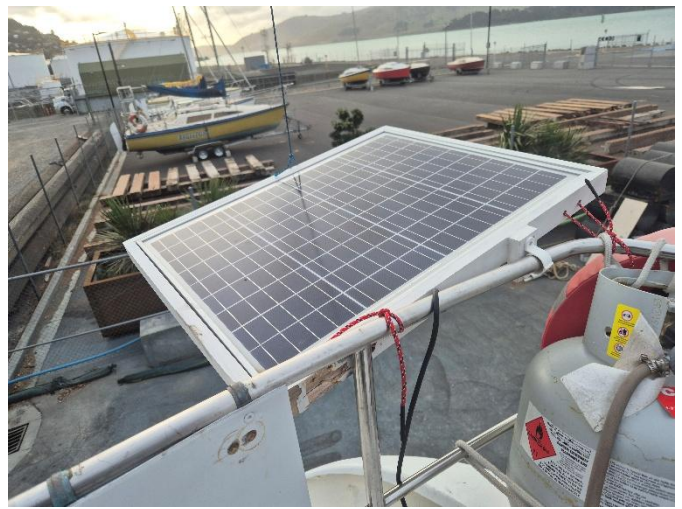
13. Electrical Systems

Electrical system is aged, however in working order.

DEF B: Much of the wiring is exposed, which whilst most of it is low voltage and low risk, is not good practice and could cause fault and safety issues.

DEF C: Port aft bunk light not working

DEF C: Light cover above chart table missing.

Batteries in good visual condition. Suitably housed and secured.

Solar panel on upper deck appears in good order.

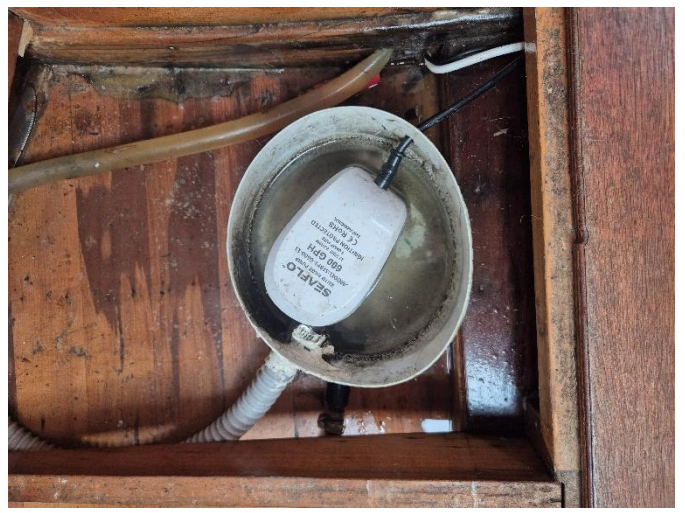
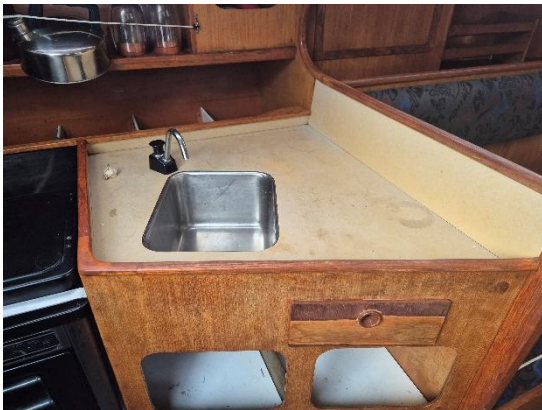
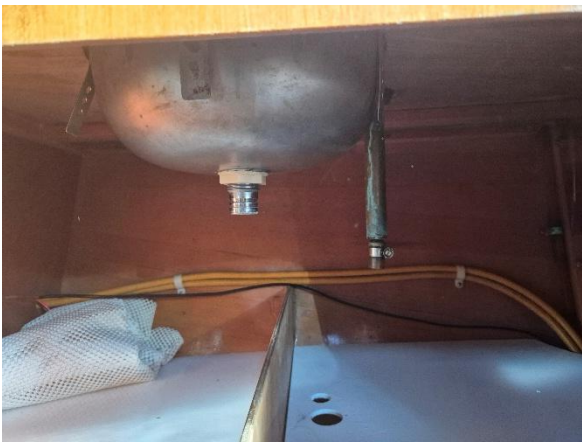
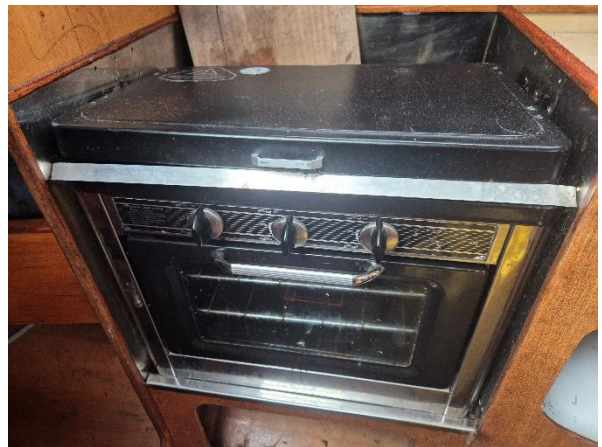
14. Galley, Bilge & Sanitary Systems

DEF B: Recommend full gas system inspection carried out.

DEF B: Unable to test bilge pumps. No marked switches. Owner to confirm they are working.

DEF C: Sink in fwd cabin not connected to FW system.

1 x Manual pump fitted.

Small kitchenette appears in good condition. Cooker not gimballed.

Gas bottles stored on upper deck, but no gas installation inspection carried out. Appears in good order where seen.

Fresh water tanks (2 x tanks, 200l total) seen externally and no issues observed.

Sinks and fresh water working correctly in galley.

Fridge/Freezer and refrigeration system aged but in working order.

Toilet system in working order.

1 x 600 GPH and 1 x 500 GPH submersible pumps fitted in main cabin. Unable to test.

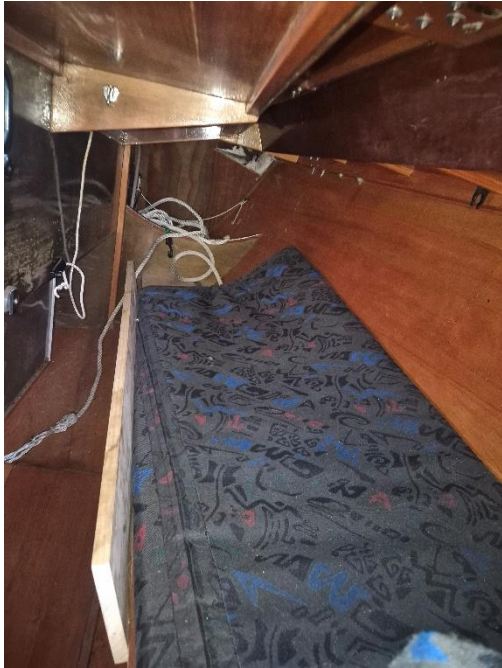
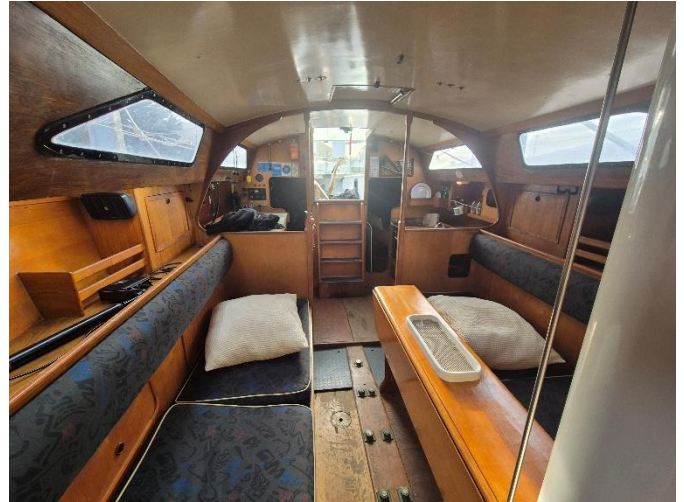
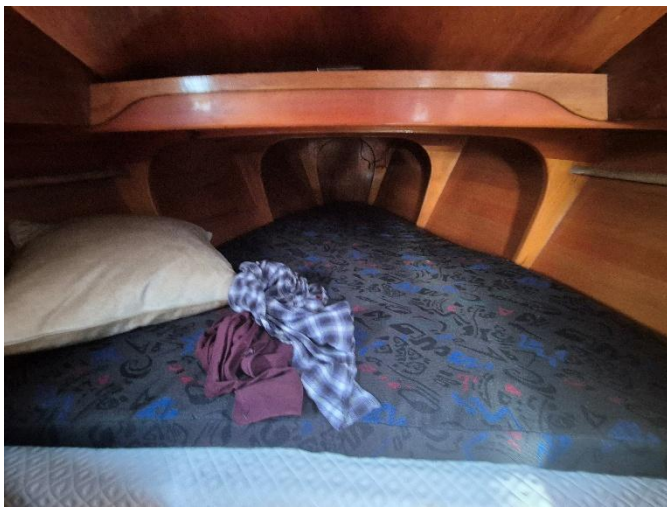
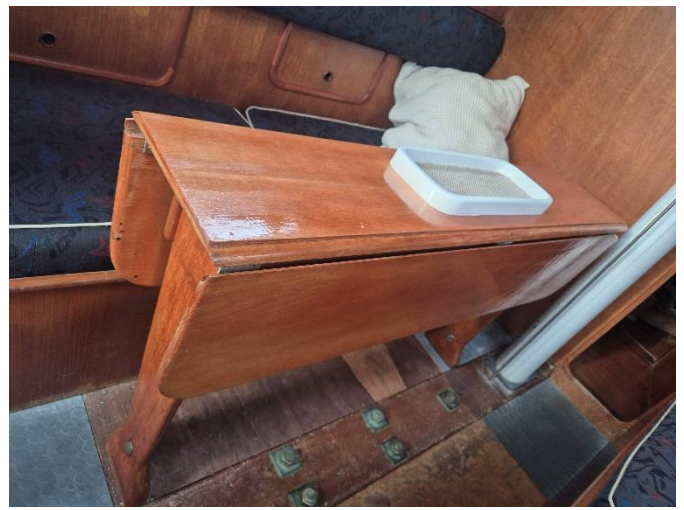
15.Accommodation

Bunk spaces in overall good condition. No signs of mould or dampness.

Mess square in clean condition, upholstery in fair condition. No signs of damp or mould.

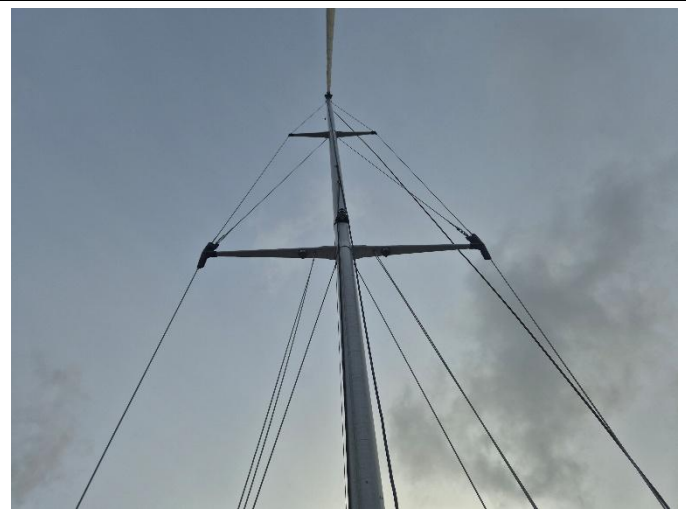
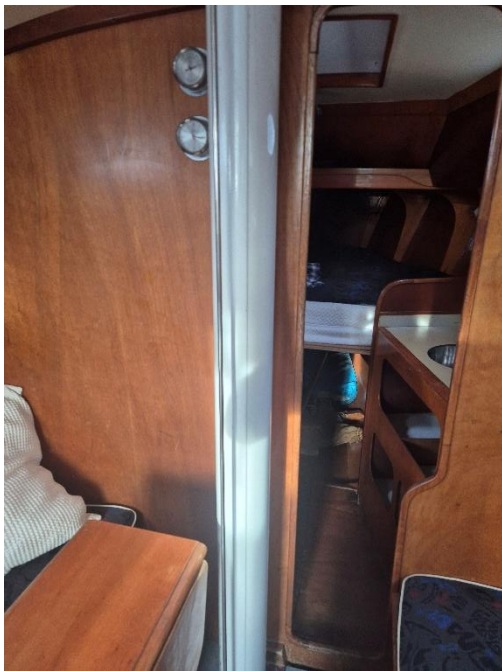
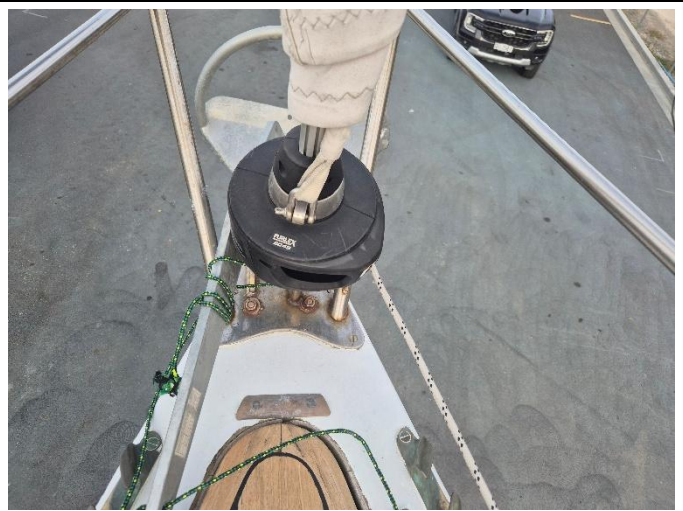
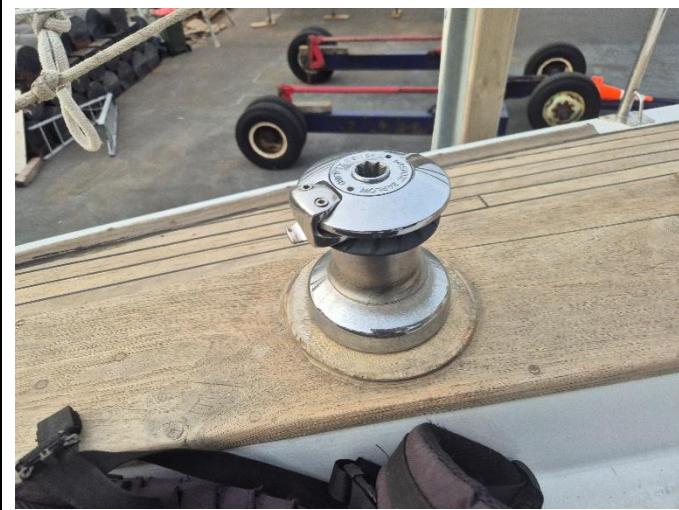
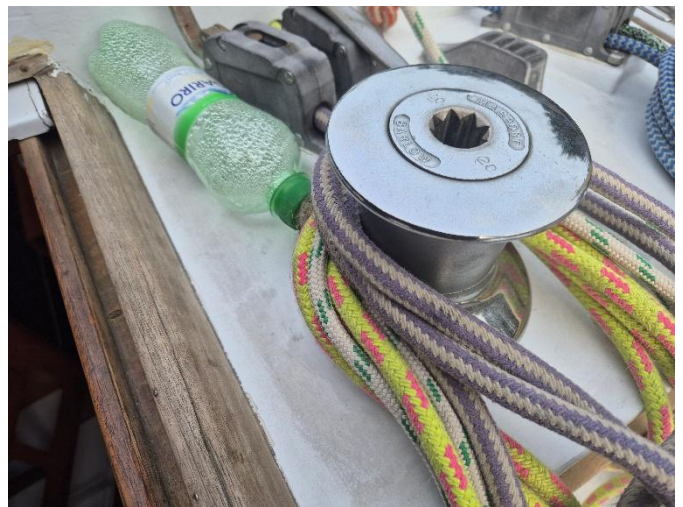
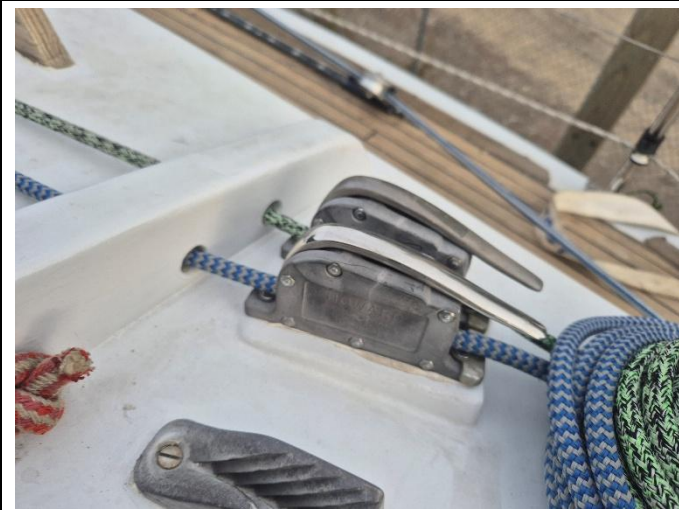
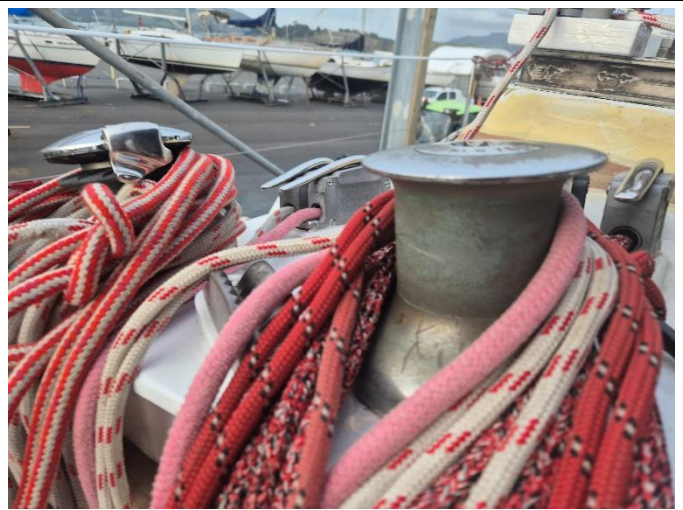
16.Mast, Sails & Rigging

Standing and vertical running rigging replaced in 2024.

Mast, boom and spars appear in good order from deck level. Mast step observed in good condition.

Chain plates seen in good condition.

Mast securing arrangements appear in good order.

All winches appear in fair condition.

All blocks, cleats and chain plates appear in fair condition.

Running rigging aged however in acceptable condition.

Main sail new in 2024, appears in good condition.

Head sail on furler installed in 2022. Seen in good condition and furler working correctly.

1 x storm jib seen in good condition.

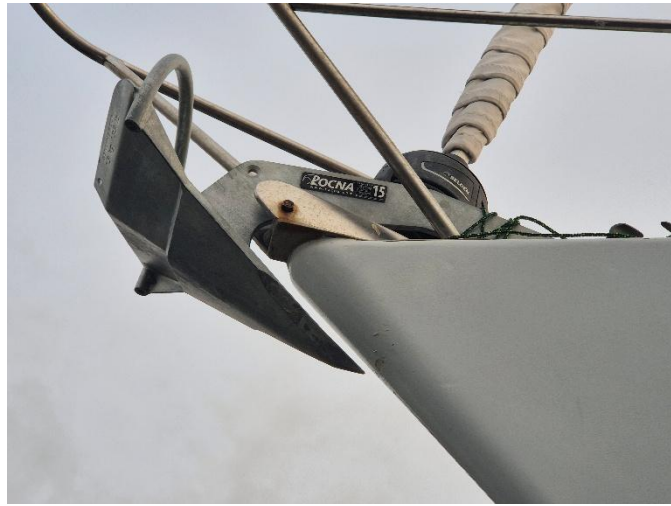
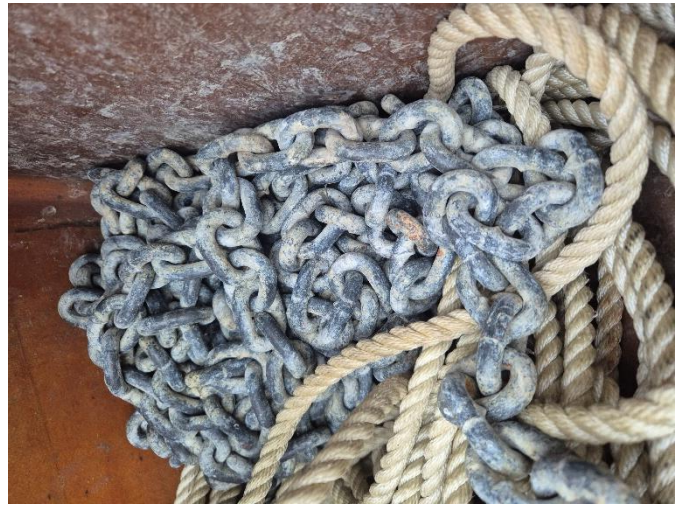
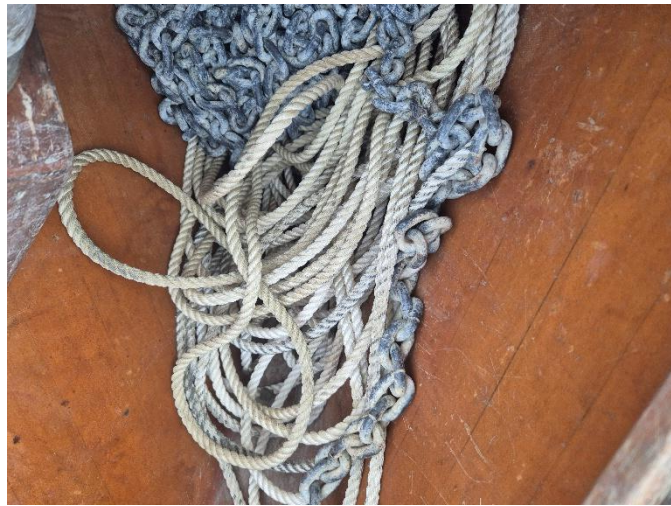
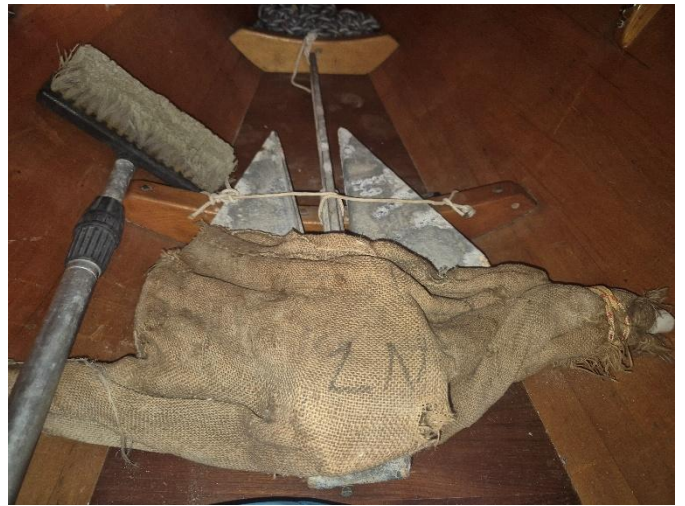
17. Anchoring Equipment

DEF B: Unable to test as engine needs to be running to operate. Owner to confirm.

Fairlead in good condition.

1 x 15kg Rocna anchor carried and 1 x Danforth spare. In good condition.

Chain seen in good condition.

1 x Anchor winch installed.

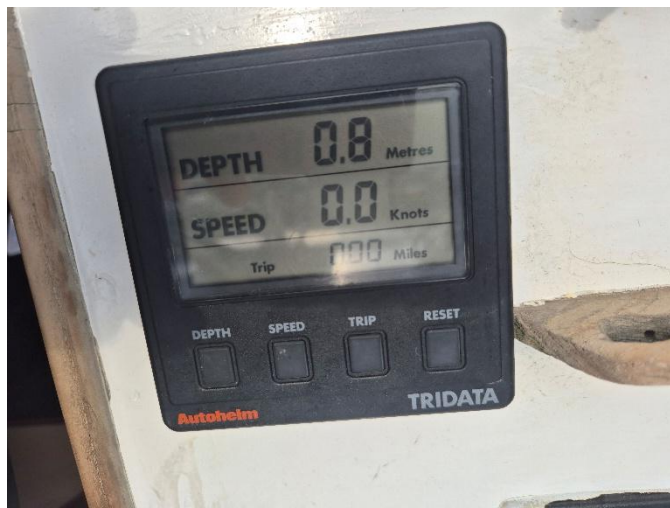
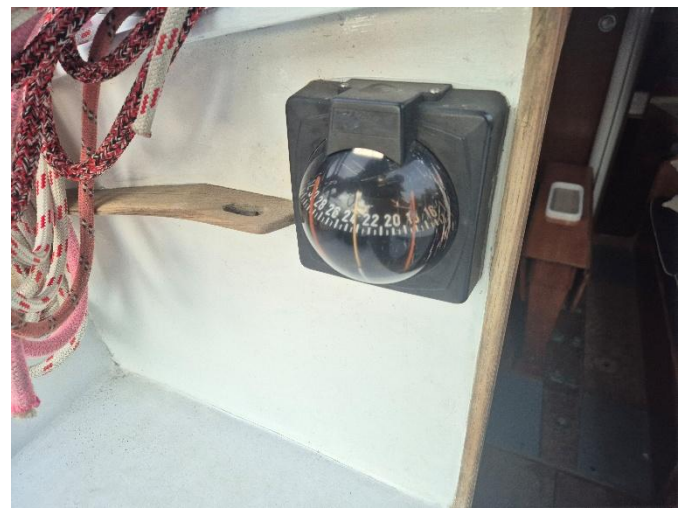
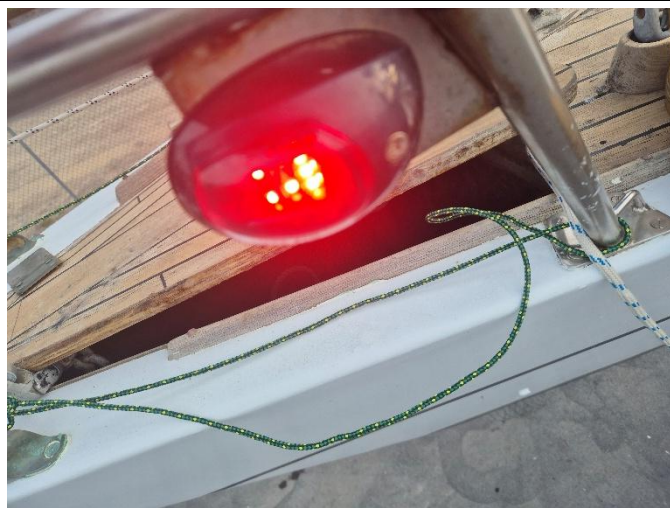
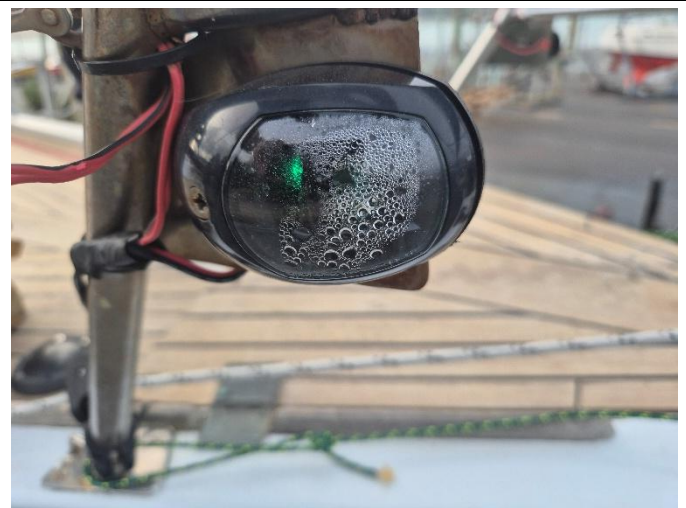
Navigation lights tested and working correctly.

No other navigational aids seen.

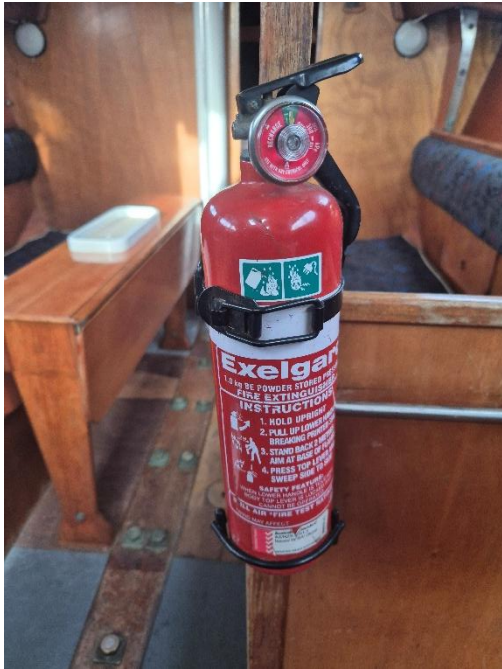
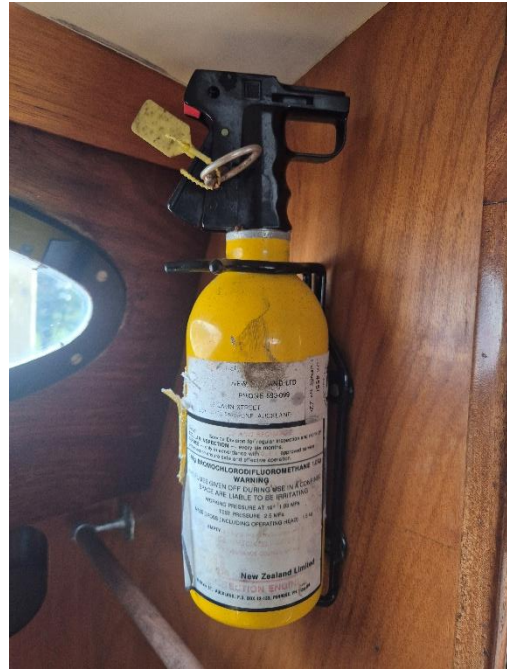
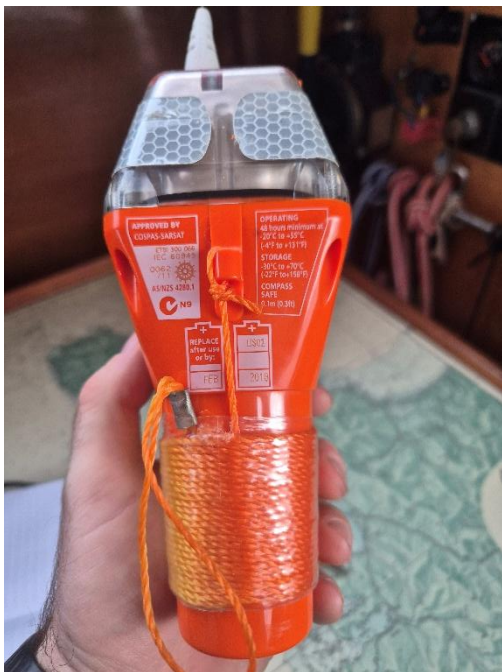
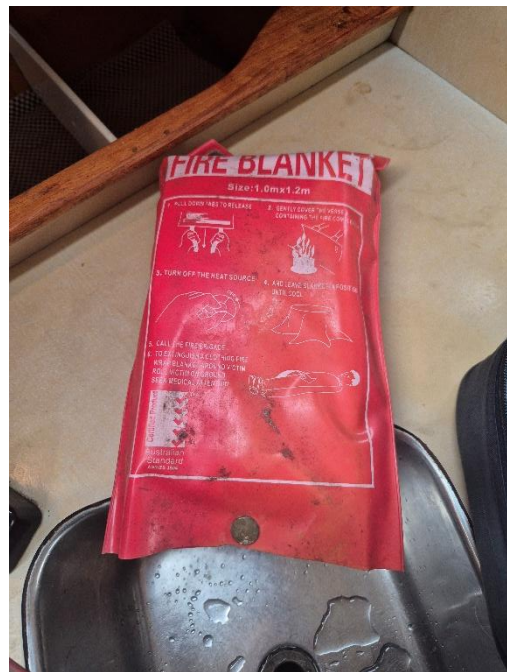
DEF B: Flares carried however out of date.

1 x first aid kit carried

2 x Small horseshoe life ring carried.
