## PRE-PURCHASE CONDITION SURVEY REPORT

*Kokah*

Date	11/09/25
Report No.	025/PSS/006

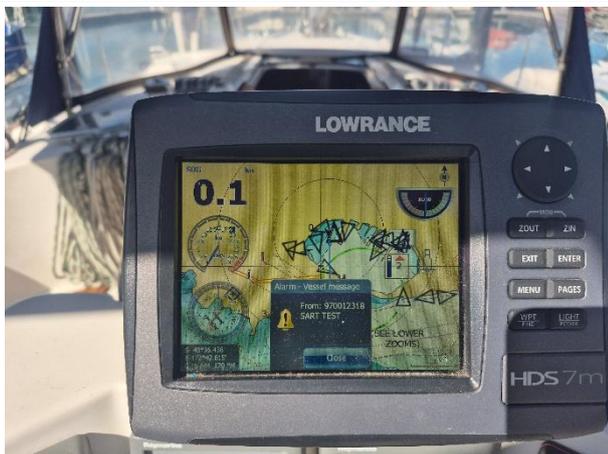
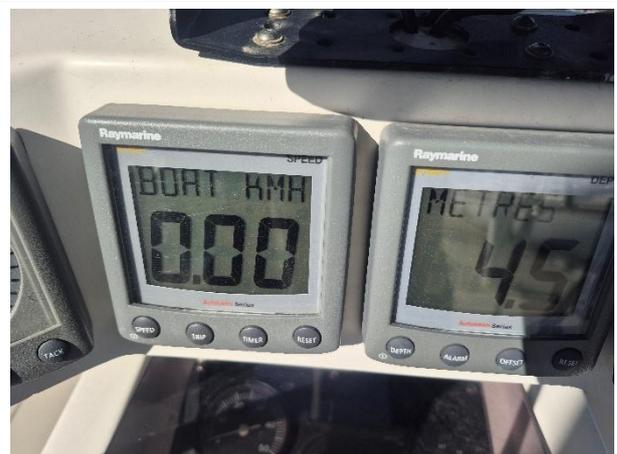
Vessel fitted with GPS plotter, AIS transceiver, wind and depth displays. All working correctly.

Navigation lights tested and working correctly.
