# PRE-PURCHASE CONDITION SURVEY REPORT

## *Mean Time*

<b>Date</b>	07/02/26
<b>Report No.</b>	026/PSS/001

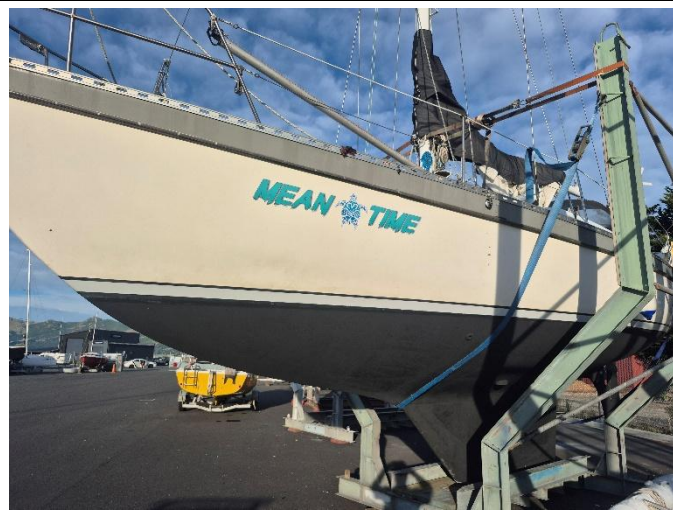
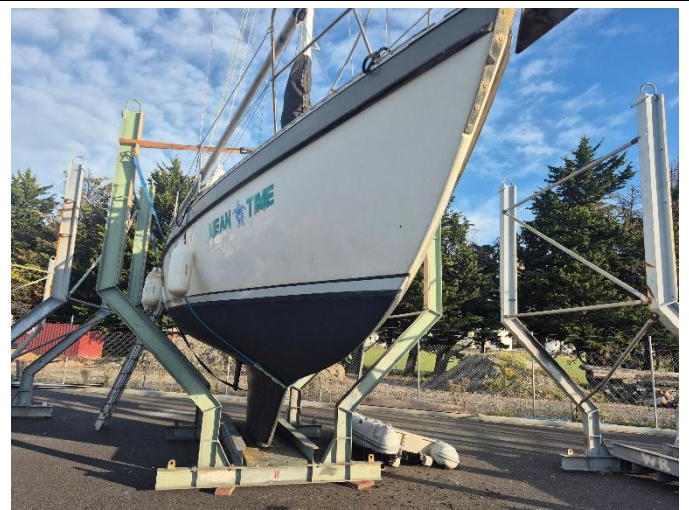
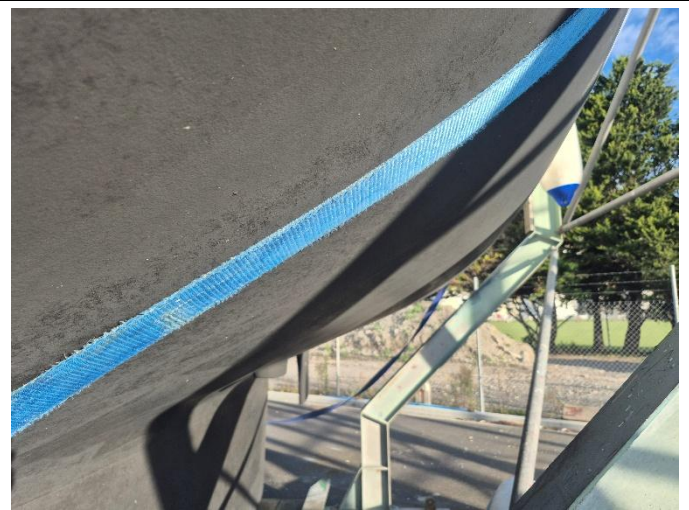
**DEF B:** Keel fin recently has run aground and has cause some damage. This is regarded as minor and was being repaired at the time of survey.

Keel Damage

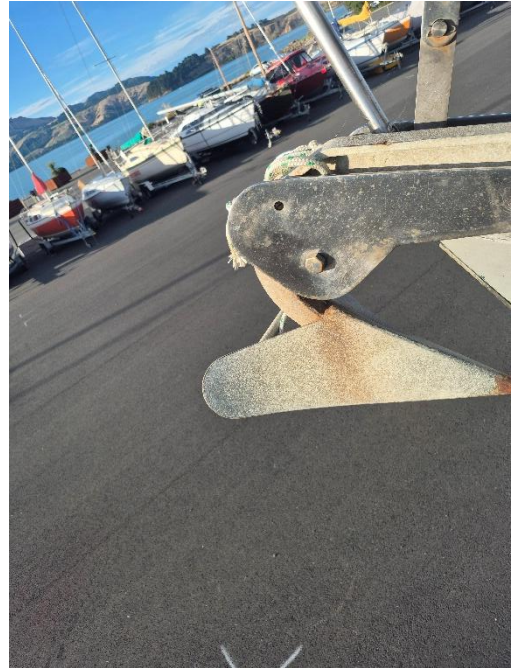
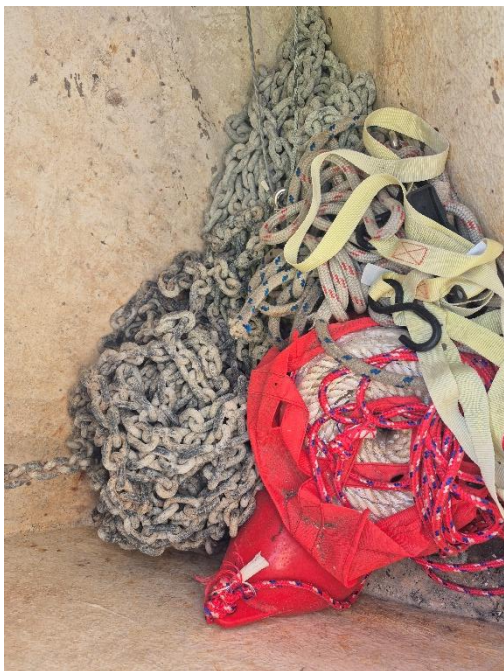
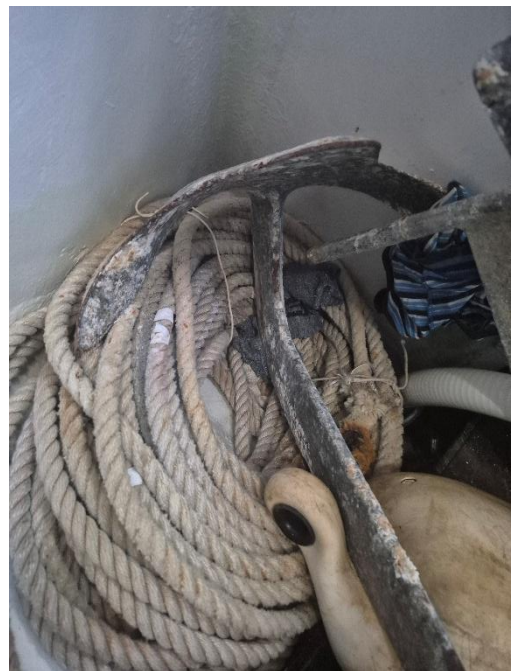
**DEF B** Windlass tested from local foot pedals however pay out button will not work.
